# Access Compliance Report Public Rights-of-Way (Curb Ramps)

Main Street: N/A Cross Street: VANDERLIP\_AVE Location: SW

ADA ID: RPAT211006094455 Ramp Type: Type 1 - Perpendicular Initial Pass/Fail: Fail Overall Compliance: No Severity Score: 2

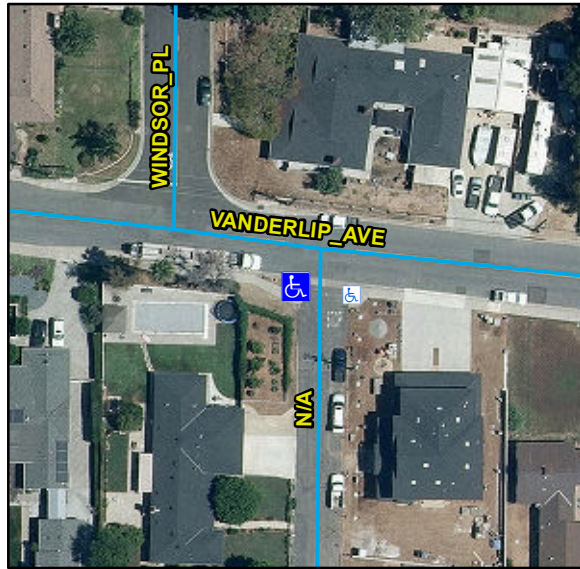
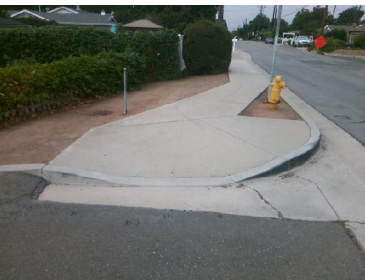
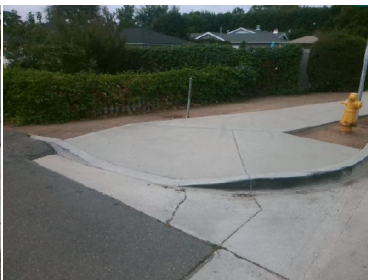
| Compliance | Description | Data | Compliance | Description | Data |
|---|---|---|---|---|---|
| No | Ramp Cross Slope (%) | 3.9 | N/A | Flare Traversable LT | N/A |
| N/A | Gutter Ponding | N/A | No | Curb Slope | 8.8 |

Possible Solutions:

Remove & Replace Entire Ramp.

R304.2.2, R204.3, R304.5.3, STD 1115

Total Cost: \$ 3080
