# Access Compliance Report Public Rights-of-Way (Curb Ramps)

Main Street: VANDERLIP\_AVE Cross Street: CAMERON\_LN Location: NW

ADA ID: RPAT211006102707 Ramp Type: Type 1 - Perpendicular Diagonal Initial Pass/Fail: Fail Overall Compliance: No Severity Score: 2

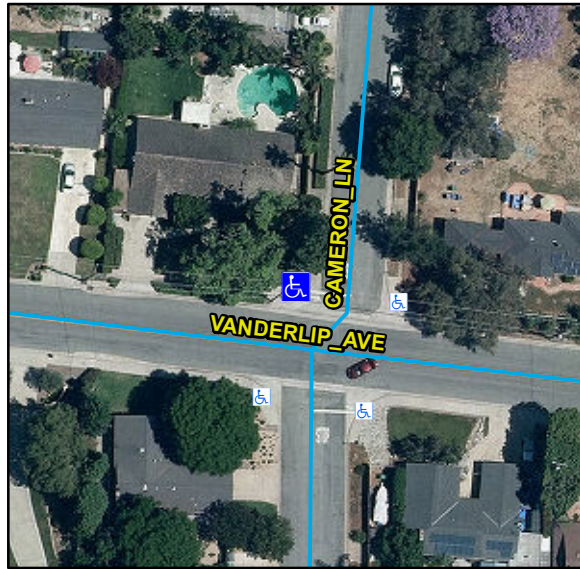
| Compliance | Description | Data | Compliance | Description | Data |
|---|---|---|---|---|---|
| No | Ramp Cross Slope (%) | 3.1 | N/A | Flare Traversable LT | N/A |

Remove & Replace Curb Ramp With Two New Directional Ramps or Equivalent.

R304.5.3, STD 1115
