# Access Compliance Report Public Rights-of-Way (Curb Ramps)

Main Street: VANDERLIP\_AVE Cross Street: CAMERON\_LN Location: SE

ADA ID: RPAT211006104518 Ramp Type: Type 4 - Parallel Initial Pass/Fail: Fail Overall Compliance: No Severity Score: 15

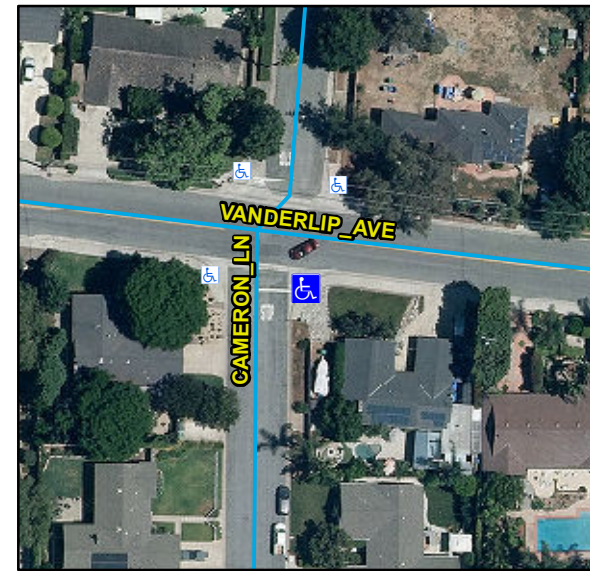
| Compliance | Description | Data | Compliance | Description | Data |
|---|---|---|---|---|---|
| No | Ramp Run Slope LT (%) | 9.9 | No | Ramp Run Slope RT (%) | 9.9 |

Remove & Replace Curb Ramp With Two New Directional Ramps or Equivalent.

R304.3.2, STD 1115

Total Cost: \$ 4000
