# Access Compliance Report Public Rights-of-Way (Curb Ramps)

Main Street: CAMERON\_LN Cross Street: VANDERLIP\_AVE Location: SW

ADA ID: RPAT211006104745 Ramp Type: Type 1 - Perpendicular Diagonal Initial Pass/Fail: Fail Overall Compliance: No Severity Score: 15

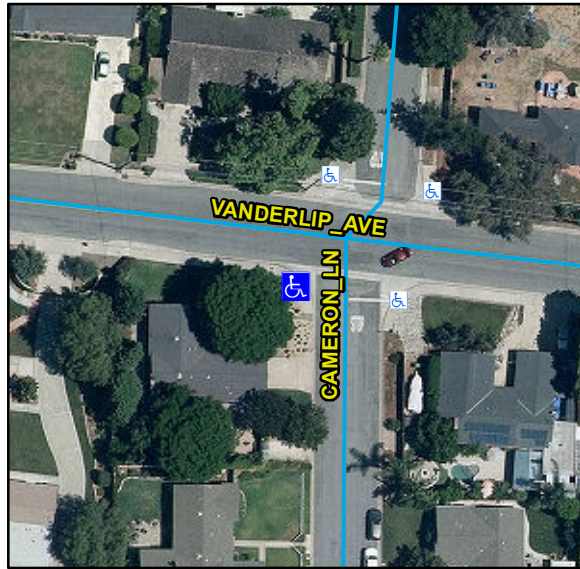
| Compliance | Description | Data | Compliance | Description | Data |
|---|---|---|---|---|---|
| No | Ramp Run Slope (%) | 8.5 | N/A | Flare Slope LT (%) | N/A |

**Remove & Replace Curb Ramp With Two New Directional Ramps or Equivalent.**

**R304.2.2, STD 1115**
