# Access Compliance Report Public Rights-of-Way (Curb Ramps)

Main Street: ETON\_PL Cross Street: AUBURN\_AVE Location: SW

ADA ID: RPAT211006131302 Ramp Type: Type 6 - Directional 1 Initial Pass/Fail: Fail Overall Compliance: No Severity Score: 5

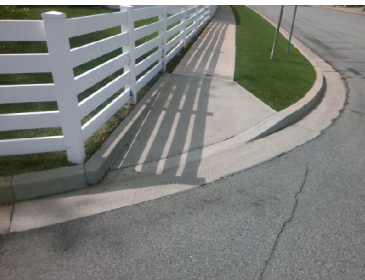
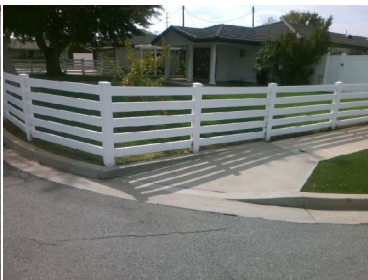
| Compliance | Description | Data | Compliance | Description | Data |
|---|---|---|---|---|---|
| No | Ramp Width (in) | 47 | | | N/A |
| No | Ramp Cross Slope (%) | 3.1 | N/A | Flare Traversable LT | N/A |

Remove & Replace Curb Ramp With Two New Directional Ramps or Equivalent.
