# Access Compliance Report Public Rights-of-Way (Curb Ramps)

Main Street: AUBURN\_AVE Cross Street: ETON\_PL Location: SE

ADA ID: RPAT211006131614 Ramp Type: Type 6 - Directional 1 Initial Pass/Fail: Fail Overall Compliance: No Severity Score: 5

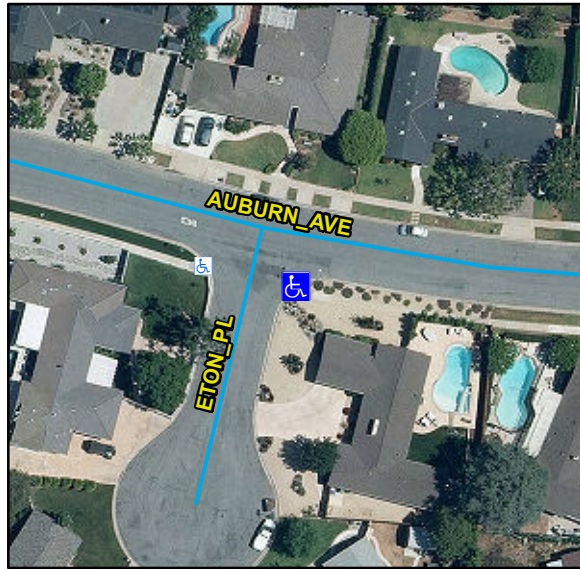
| Compliance | Description | Data | Compliance | Description | Data |
|---|---|---|---|---|---|
| No | Ramp Width (in) | 47 | | | N/A |

**Remove & Replace Curb Ramp With Two New Directional Ramps or Equivalent.**

**R304.5.1, STD 1115**
