# Access Compliance Report Public Rights-of-Way (Curb Ramps)

Main Street: AUBURN\_AVE Cross Street: STRATTON\_WAY Location: SW

ADA ID: RPAT211006132050 Ramp Type: Type 6 - Directional 1 Initial Pass/Fail: Fail Overall Compliance: No Severity Score: 2

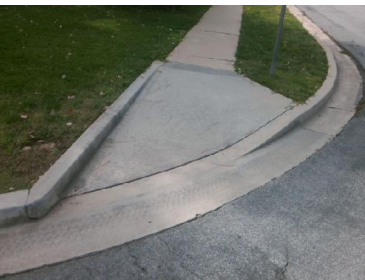
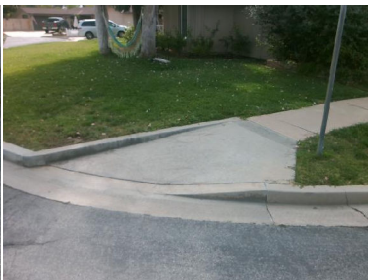
| Compliance | Description | Data | Compliance | Description | Data |
|---|---|---|---|---|---|
| No | Ramp Cross Slope (%) | 2.2 | N/A | Flare Traversable LT | N/A |

**Remove & Replace Curb Ramp With Two New Directional Ramps or Equivalent.**

**R304.5.3, STD 1115**
