# Access Compliance Report Public Rights-of-Way (Curb Ramps)

Main Street: AUBURN\_AVE Cross Street: STRATTON\_WAY Location: SE

ADA ID: RPAT211006132453 Ramp Type: Type 6 - Directional 1 Initial Pass/Fail: Fail Overall Compliance: No Severity Score: 2

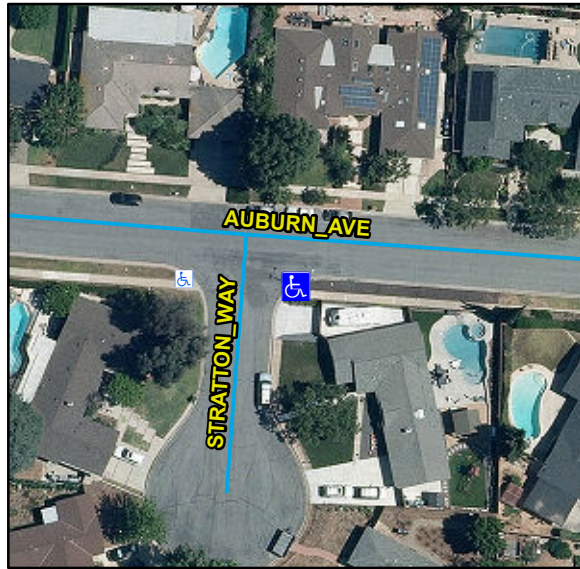
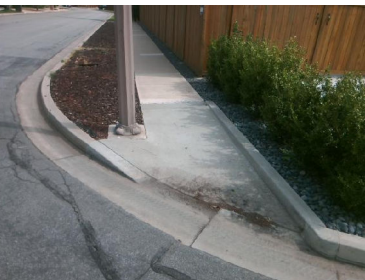
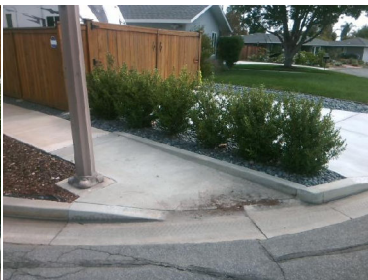
| Compliance | Description | Data | Compliance | Description | Data |
|---|---|---|---|---|---|
| No | Ramp Cross Slope (%) | 4.3 | N/A | Flare Traversable LT | N/A |

Remove & Replace Curb Ramp With Two New Directional Ramps or Equivalent.

R304.5.3, STD 1115
