# Access Compliance Report Public Rights-of-Way (Curb Ramps)

Main Street: SANDHURST\_ST Cross Street: AUBURN\_AVE Location: SW

ADA ID: RPAT211006132900 Ramp Type: Type 6 - Directional 1 Initial Pass/Fail: Fail Overall Compliance: No Severity Score: 5

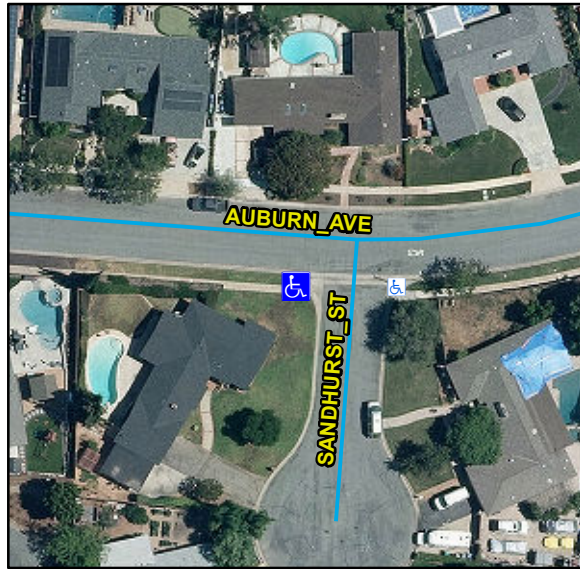
| Compliance | Description | Data | Compliance | Description | Data |
|---|---|---|---|---|---|
| No | Ramp Width (in) | 47 | | | N/A |
| No | Ramp Cross Slope (%) | 2.9 | N/A | Flare Traversable LT | N/A |

**Remove & Replace Curb Ramp With Two New Directional Ramps or Equivalent.**

**R304.5.1, R304.5.3, STD 1115**
