# Access Compliance Report Public Rights-of-Way (Curb Ramps)

Main Street: AUBURN\_AVE Cross Street: SANDHURST\_ST Location: SE

ADA ID: RPAT211006133116 Ramp Type: Type 6 - Directional 1 Initial Pass/Fail: Pass Overall Compliance: No Severity Score: 18

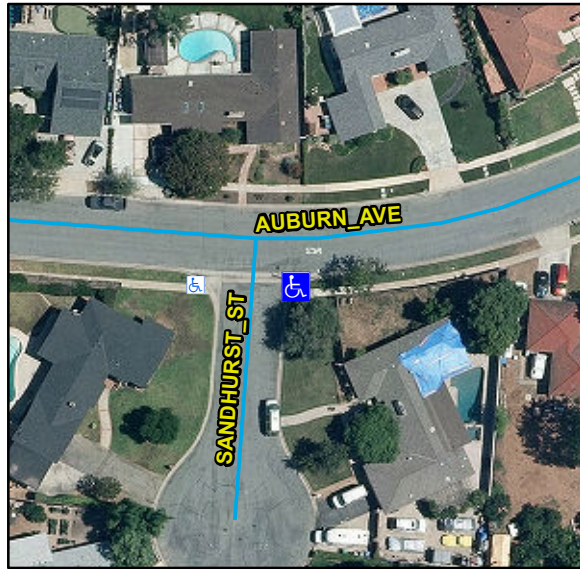
| Compliance | Description | Data | Compliance | Description | Data |
|---|---|---|---|---|---|
| No | Grade Break | No | Yes | Flare Type RT | |
| | Addl Para Ramp Right? | No | No | DWS Provided | No |
| No | Landing Length (in) | 32 | N/A | DWS Length (in) | N/A |
| No | Landing Width (in) | 47 | N/A | DWS Full Width | N/A |
| No | Landing Cross Slope (%) | 3.5 | N/A | DWS Left Offset (in) | N/A |

Remove & Replace Curb Ramp With Two New Directional Ramps or Equivalent. Utility Present.

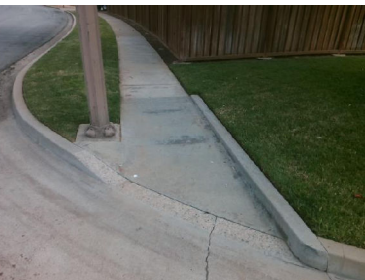
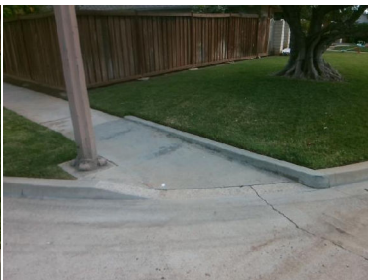
| Compliance | Description | Data | Compliance | Description | Data |
|---|---|---|---|---|---|
| Yes | Overall Surface Condition | Acceptable | Yes | Perp Joint Present | Yes |
