# Access Compliance Report Public Rights-of-Way (Curb Ramps)

Main Street: AUBURN\_AVE Cross Street: WINTHROPE\_ST Location: SW

ADA ID: RPAT211006133804 Ramp Type: Type 6 - Directional 1 Initial Pass/Fail: Fail Overall Compliance: No Severity Score: 5

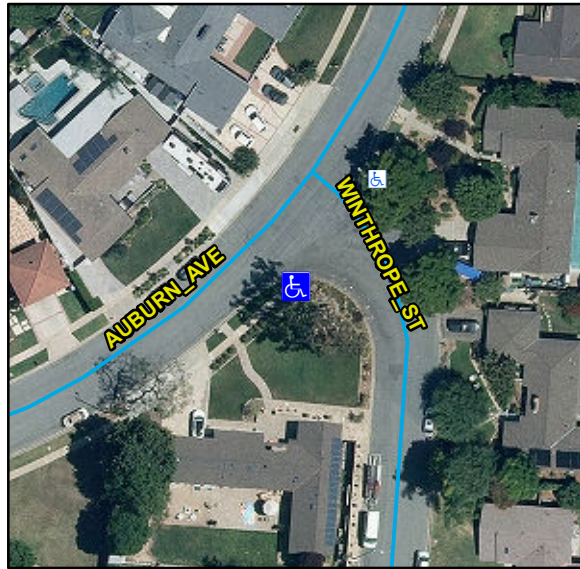
| Compliance | Description | Data | Compliance | Description | Data |
|---|---|---|---|---|---|
| No | Ramp Width (in) | 47 | | | N/A |
| No | Ramp Cross Slope (%) | 3.9 | N/A | Flare Traversable LT | N/A |

**Remove & Replace Curb Ramp With Two New Directional Ramps or Equivalent.**

**R304.5.1, R304.5.3, STD 1115**
