# Access Compliance Report Public Rights-of-Way (Curb Ramps)

| Main Street: WINTHROPE_ST | | Cross Street: WINTHROPE_ST | | Location: | SE |
| ADA ID: RPAT211006134332 | Ramp Type: Type 6 - Directional 1 | Initial Pass/Fail: Pass | Overall Compliance: No | Severity Score: | 15 |

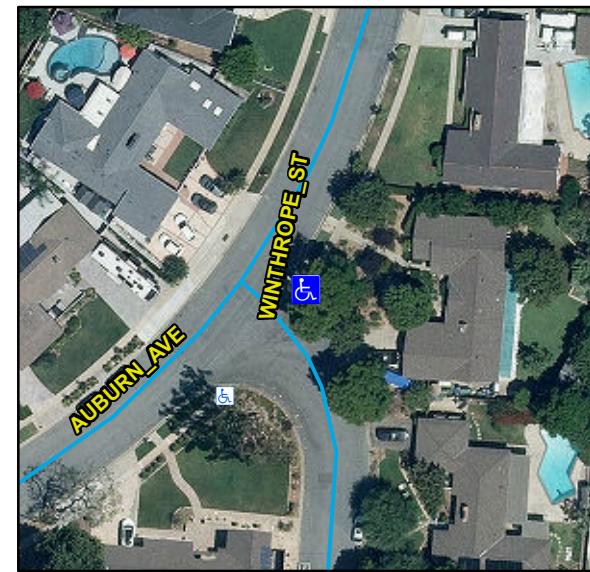
**Remove & Replace Curb Ramp With Two New Directional Ramps or Equivalent. Gutter Ponding Observed.**

| Compliance | Description | Data | Compliance | Description | Data |
|---|---|---|---|---|---|
| No | Grade Break | No | Yes | Flare Type RT | |
| No | Landing Run Slope (%) | 5.3 | | DWS Offset Type | N/A |
| No | Landing Cross Slope (%) | 5 | N/A | DWS Left Offset (in) | N/A |
| No | Gutter Ponding | Yes | Yes | Curb Slope | 4.9 |

Possible Solutions:
