# Access Compliance Report Public Rights-of-Way (Curb Ramps)

Main Street: **BRENAN\_WAY** Cross Street: **AUBURN\_AVE** Location: **NE**

ADA ID: **RPAT211006135857** Ramp Type: **Type 4 - Parallel** Initial Pass/Fail: **Pass** Overall Compliance: **No** Severity Score: **2**

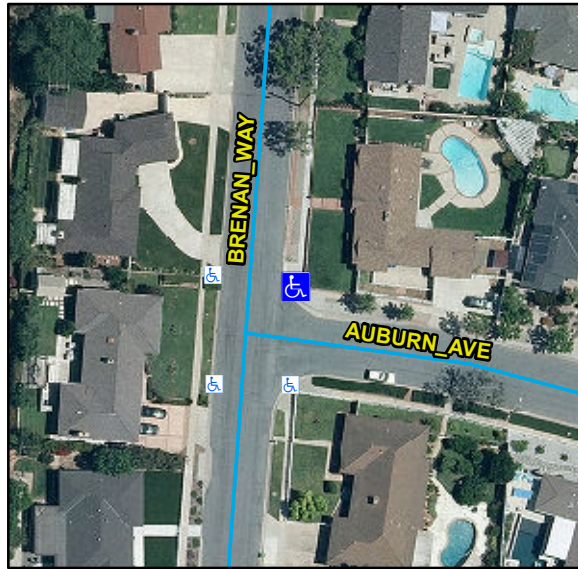
| Compliance | Description | Data | Compliance | Description | Data |
|---|---|---|---|---|---|
| <b>Yes</b> | Ramp Cross Slope LT (%) | <b>2</b> | <b>No</b> | Ramp Cross Slope RT (%) | <b>2.9</b> |
| <b>No</b> | Landing Run Slope (%) | <b>2.7</b> | <b>Yes</b> | DWS Full Width | <b>Yes</b> |
| <b>No</b> | Gutter Ponding | <b>Yes</b> | <b>N/A</b> | Curb Slope | <b>7.6</b> |

**Remove & Replace Curb Ramp With Two New Directional Ramps or Equivalent. Gutter Ponding Observed.**
