# Access Compliance Report Public Rights-of-Way (Curb Ramps)

Main Street: BEACHMONT\_AVE Cross Street: ETON\_PL Location: NW

ADA ID: RPAT211006145030 Ramp Type: Type 1 - Perpendicular Diagonal Initial Pass/Fail: Pass Overall Compliance: No Severity Score: 20

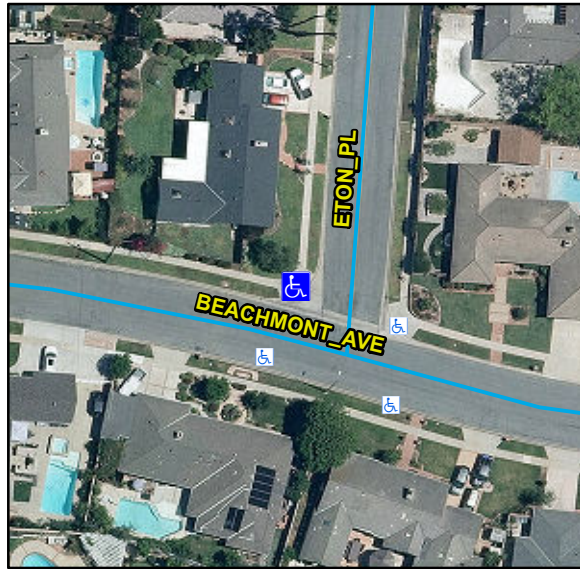
| Compliance | Description | Data | Compliance | Description | Data |
|---|---|---|---|---|---|
| No | Landing Width (in) | N/A | N/A | Flare Slope RT (%) | 8.9 |
| No | Landing Run Slope (%) | N/A | N/A | Flare Traversable RT | No |
| No | Landing Cross Slope (%) | N/A | No | DWS Provided | No |

Remove & Replace Curb Ramp With Two New Directional Ramps or Equivalent.
