# Access Compliance Report Public Rights-of-Way (Curb Ramps)

Main Street: ETON\_PL Cross Street: BEACHMONT\_AVE Location: NE

ADA ID: RPAT211006145340 Ramp Type: Type 1 - Perpendicular Diagonal Initial Pass/Fail: Fail Overall Compliance: No Severity Score: 16

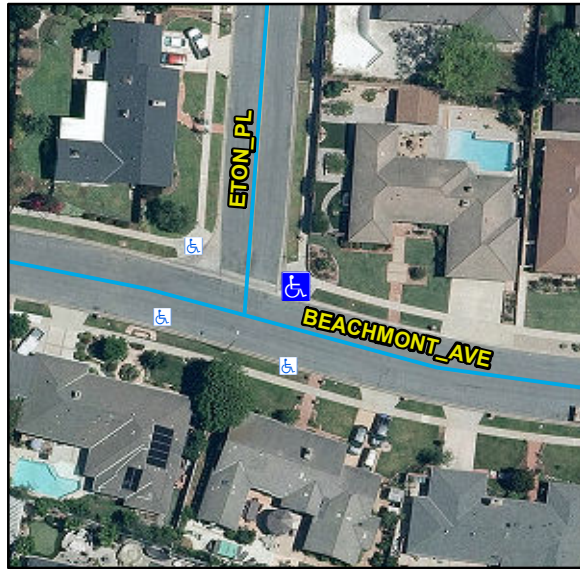
| Compliance | Description | Data | Compliance | Description | Data |
|---|---|---|---|---|---|
| No | Ramp Run Slope (%) | 8.4 | N/A | Flare Slope LT (%) | N/A |

Remove & Replace Curb Ramp With Two New Directional Ramps or Equivalent.

R304.2.2, STD 1115
