# Access Compliance Report Public Rights-of-Way (Curb Ramps)

Main Street: MEDFORD\_RD Cross Street: ETON\_PL Location: SE

ADA ID: RPAT211006145708 Ramp Type:Type 1 - Perpendicular Diagonal Initial Pass/Fail: Fail Overall Compliance: No Severity Score: 2

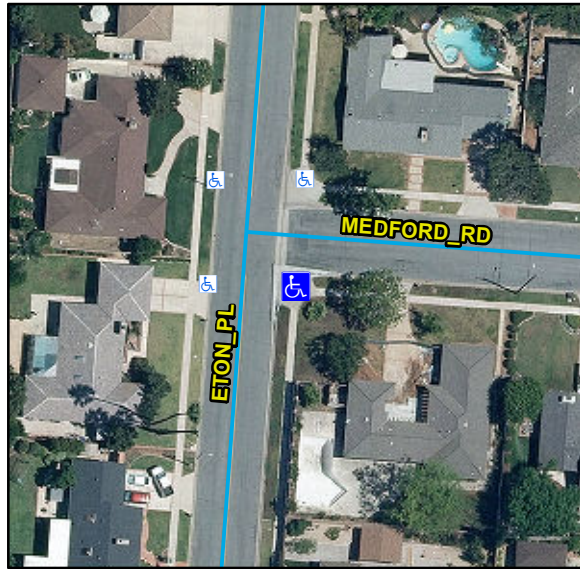
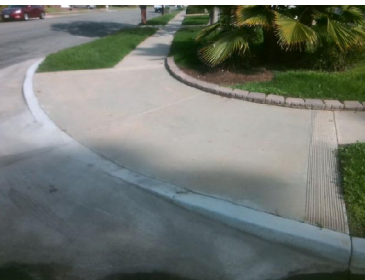
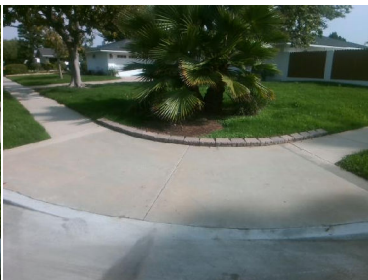
| Compliance | Description | Data | Compliance | Description | Data |
|---|---|---|---|---|---|
| No | Ramp Cross Slope (%) | 4.1 | N/A | Flare Traversable LT | N/A |

Remove & Replace Curb Ramp With Two New Directional Ramps or Equivalent.
