# Access Compliance Report Public Rights-of-Way (Curb Ramps)

Main Street: ETON\_PL Cross Street: MEDFORD\_RD Location: NE

ADA ID: RPAT211006150042 Ramp Type: Type 1 - Perpendicular Diagonal Initial Pass/Fail: Fail Overall Compliance: No Severity Score: 16

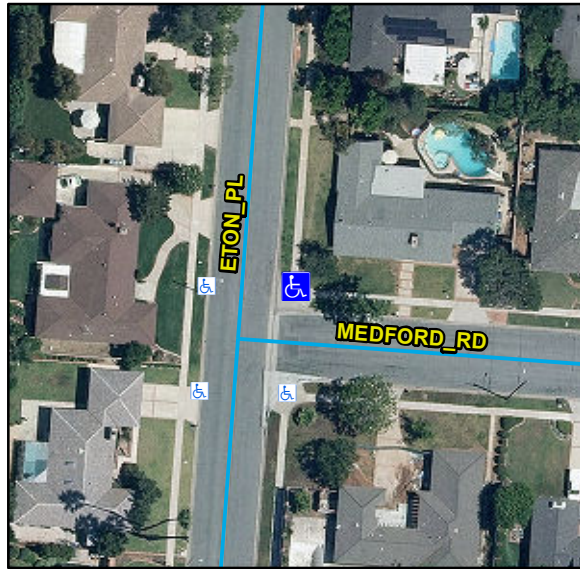
| Compliance | Description | Data | Compliance | Description | Data |
|---|---|---|---|---|---|
| No | Ramp Run Slope (%) | 8.6 | N/A | Flare Slope LT (%) | N/A |
| N/A | Gutter Ponding | N/A | No | Curb Slope | 9.2 |

**Remove & Replace Curb Ramp With Two New Directional Ramps or Equivalent.**

**R304.2.2, STD 1115**
