# Access Compliance Report Public Rights-of-Way (Curb Ramps)

Main Street: ERVIN\_LN Cross Street: NEWTON\_AVE Location: NE

ADA ID: RPAT211006150937 Ramp Type: Type 1 - Perpendicular Diagonal Initial Pass/Fail: Pass Overall Compliance: No Severity Score: 22

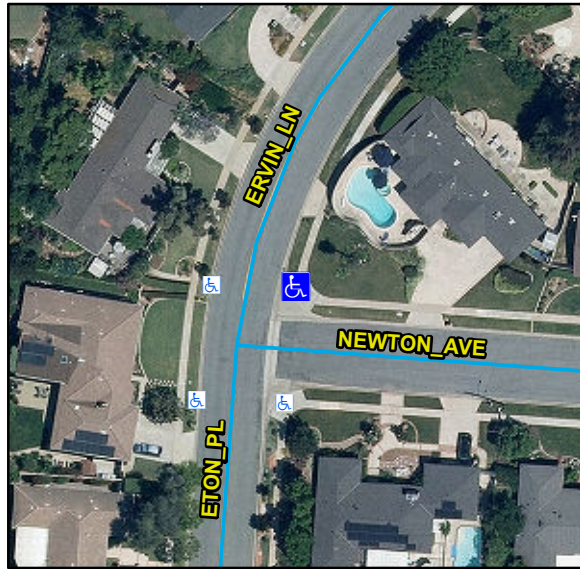
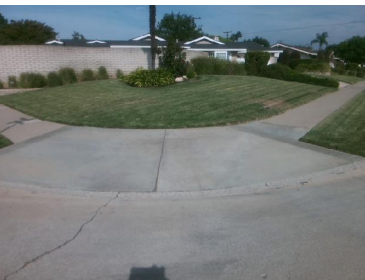
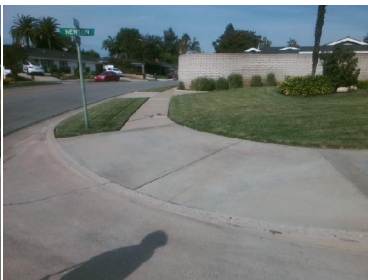
| Compliance | Description | Data | Compliance | Description | Data |
|---|---|---|---|---|---|
| No | Landing Width (in) | N/A | N/A | Flare Slope RT (%) | 5.4 |
| No | Landing Run Slope (%) | N/A | N/A | Flare Traversable RT | No |
| No | Landing Cross Slope (%) | N/A | No | DWS Provided | No |
| Yes | Gutter Ponding | No | No | Curb Slope | 6.4 |

Remove & Replace Curb Ramp With Two New Directional Ramps or Equivalent.
