# Access Compliance Report Public Rights-of-Way (Curb Ramps)

Main Street: HILLHAVEN\_DR Cross Street: SANDHURST\_PL Location: SE

ADA ID: RPAT211007095521 Ramp Type: Type 1 - Perpendicular Diagonal Initial Pass/Fail: Fail Overall Compliance: No Severity Score: 5

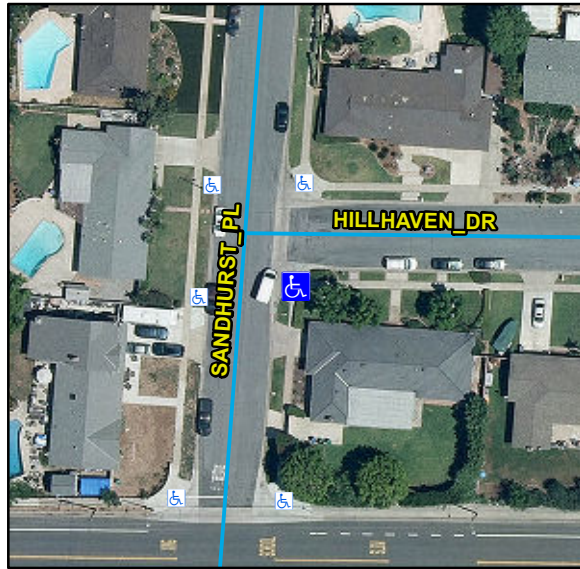
| Compliance | Description | Data | Compliance | Description | Data |
|---|---|---|---|---|---|
| No | Ramp Width (in) | 46 | | | N/A |

**Remove & Replace Curb Ramp With Two New Directional Ramps or Equivalent.**

**R304.2.2, R304.5.1, STD 1115**
