# Access Compliance Report Public Rights-of-Way (Curb Ramps)

Main Street: SANDHURST\_PL Cross Street: HILLHAVEN\_DR Location: NE

ADA ID: RPAT211007095849 Ramp Type: Type 1 - Perpendicular Diagonal Initial Pass/Fail: Pass Overall Compliance: No Severity Score: 22

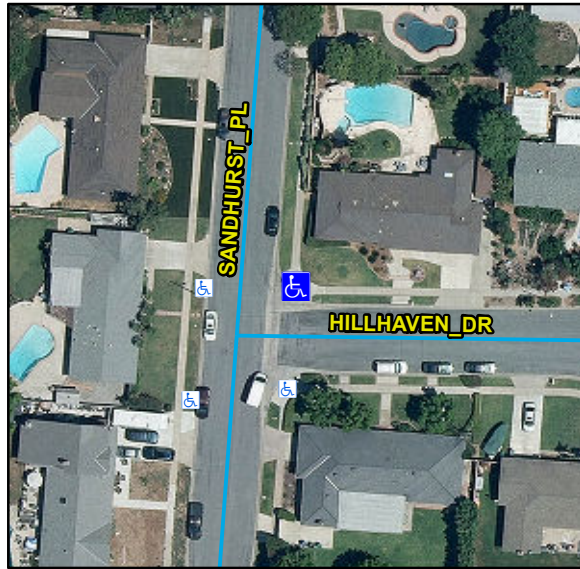
| Compliance | Description | Data | Compliance | Description | Data |
|---|---|---|---|---|---|
| No | Landing Width (in) | N/A | N/A | Flare Slope RT (%) | 4 |
| No | Landing Run Slope (%) | N/A | N/A | Flare Traversable RT | No |
| No | Landing Cross Slope (%) | N/A | No | DWS Provided | No |
| Yes | Gutter Ponding | No | No | Curb Slope | 8.1 |

Remove & Replace Curb Ramp With Two New Directional Ramps or Equivalent.
