# Access Compliance Report Public Rights-of-Way (Curb Ramps)

Main Street: OAK RIDGE\_DR Cross Street: SANDHURST\_PL Location: SE

ADA ID: RPAT211007100510 Ramp Type: Type 1 - Perpendicular Diagonal Initial Pass/Fail: Pass Overall Compliance: No Severity Score: 22

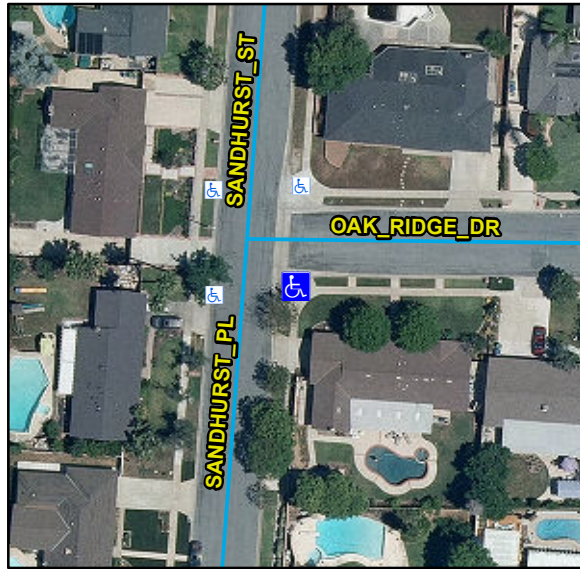
| Compliance | Description | Data | Compliance | Description | Data |
|---|---|---|---|---|---|
| No | Ramp Cross Slope (%) | 3.6 | N/A | Flare Traversable LT | No |
| No | Landing Width (in) | N/A | N/A | Flare Slope RT (%) | 3 |
| No | Landing Run Slope (%) | N/A | N/A | Flare Traversable RT | No |
| No | Landing Cross Slope (%) | N/A | No | DWS Provided | No |
| Yes | Gutter Ponding | No | No | Curb Slope | 9.8 |
| No | Gutter Cross Slope (%) | 2.6 | | | |

Remove & Replace Curb Ramp With Two New Directional Ramps or Equivalent. Remove & Replace Gutter.
