# Access Compliance Report Public Rights-of-Way (Curb Ramps)

Main Street: SANDHURST\_ST Cross Street: OAK\_RIDGE\_DR Location: NE

ADA ID: RPAT211007100831 Ramp Type: Type 1 - Perpendicular Diagonal Initial Pass/Fail: Fail Overall Compliance: No Severity Score: 4

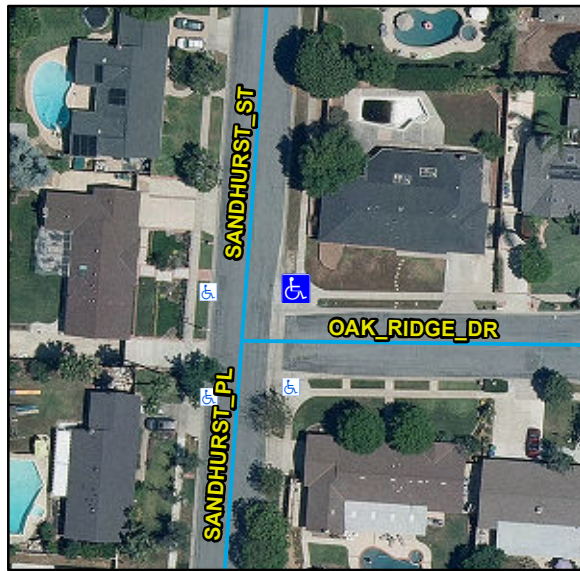
| Compliance | Description | Data | Compliance | Description | Data |
|---|---|---|---|---|---|
| No | Ramp Width (in) | 45 | | | N/A |

Remove & Replace Curb Ramp With Two New Directional Ramps or Equivalent.

R304.2.2, R304.5.1, STD 1115
