# Access Compliance Report Public Rights-of-Way (Curb Ramps)

| Main Street: OAK_RIDGE_DR | | Cross Street: WINTHROPE_ST | | Location: | NW |
| ADA ID: RPAT211007101920 | Ramp Type:Type 1 - Perpendicular Diagonal Initial Pass/Fail: Pass | | Overall Compliance: No | Severity Score: | 22 |

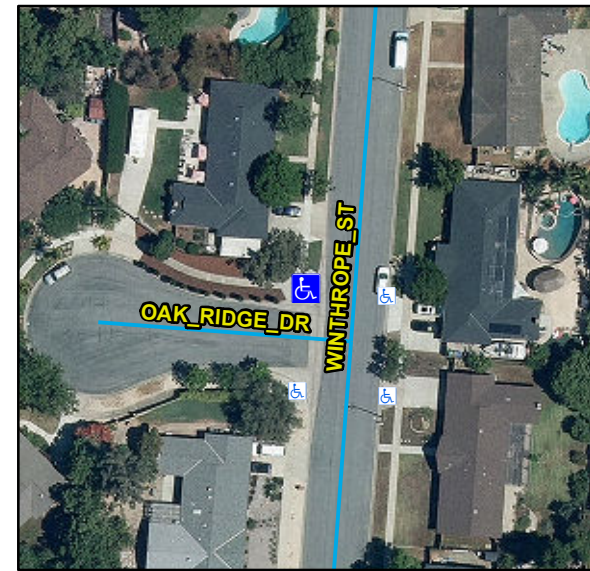
**R304.2.2, R204.3, R304.2.1, R304.2.2-Perp, R304.3.2-Para, R304.5.3, R305, STD 1115**

**Remove & Replace Curb Ramp With Two New Directional Ramps or Equivalent.**

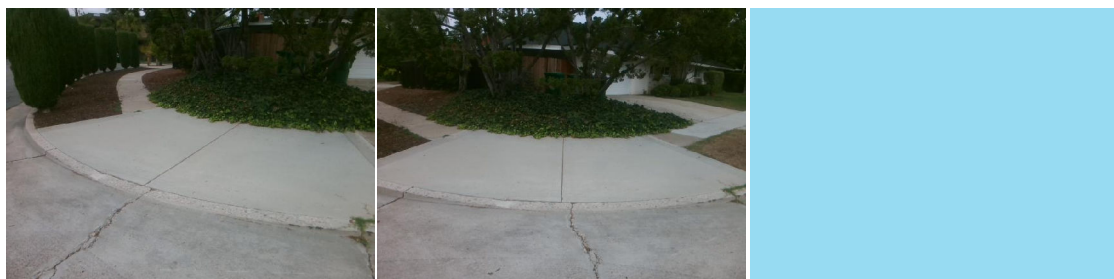
| Compliance | Description | Data | Compliance | Description | Data |
|---|---|---|---|---|---|
| No | Landing Width (in) | N/A | N/A | Flare Slope RT (%) | 3.2 |
| No | Landing Run Slope (%) | N/A | N/A | Flare Traversable RT | No |
| No | Landing Cross Slope (%) | N/A | No | DWS Provided | No |
| | Landing Movement Type | Bushes | N/A | DWS Length (in) | N/A |
| Yes | Gutter Ponding | No | No | Curb Slope | 12.4 |
| Yes | Overall Surface Condition: Acceptable | | No | Perp Joint Present | No |
