# Access Compliance Report Public Rights-of-Way (Curb Ramps)

Main Street: WINTHROPE\_ST Cross Street: OAK\_RIDGE\_DR Location: SW

ADA ID: RPAT211007102501 Ramp Type: Type 1 - Perpendicular Diagonal Initial Pass/Fail: Fail Overall Compliance: No Severity Score: 2

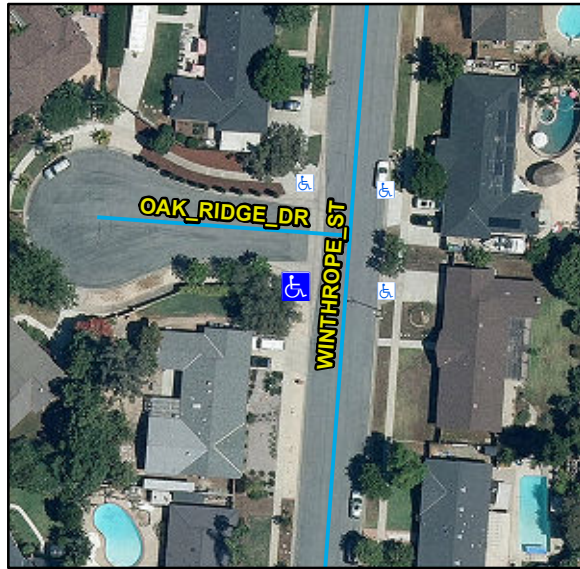
| Compliance | Description | Data | Compliance | Description | Data |
|---|---|---|---|---|---|
| No | Ramp Cross Slope (%) | 4.6 | N/A | Flare Traversable LT | N/A |

Remove & Replace Curb Ramp With Two New Directional Ramps or Equivalent.

R304.2.2, R304.5.3, STD 1115
