# Access Compliance Report Public Rights-of-Way (Curb Ramps)

Main Street: WINTHROPE\_ST Cross Street: HILLHAVEN\_DR Location: SW

ADA ID: RPAT211007103640 Ramp Type: Type 1 - Perpendicular Diagonal Initial Pass/Fail: Pass Overall Compliance: No Severity Score: 12

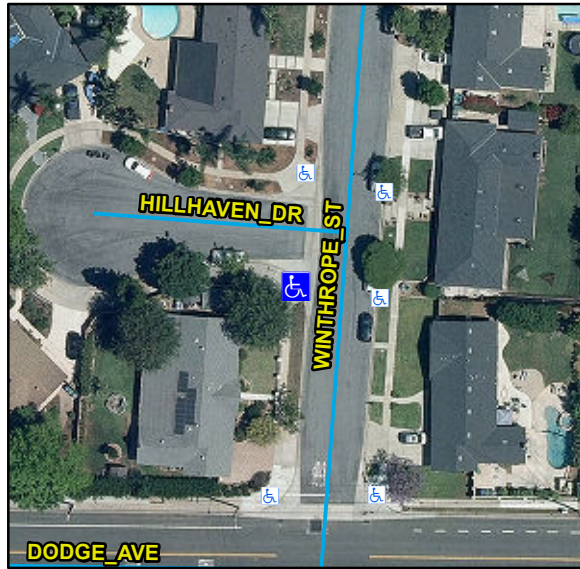
R304.2.2, R204.3, R304.2.1, R304.2.2-Perp, R304.3.2-Para, R304.5.3, STD 1115

Remove & Replace Curb Ramp With Two New Directional Ramps or Equivalent. Remove & Replace Gutter.

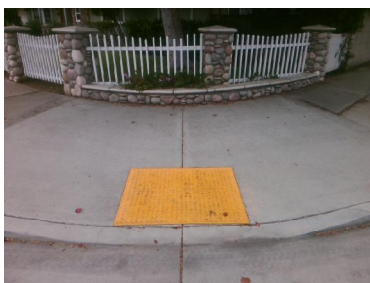
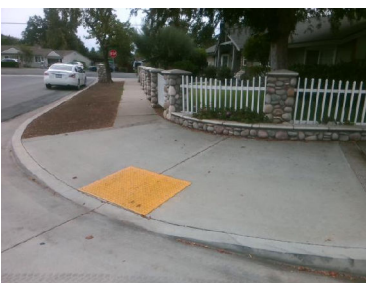
| Compliance | Description | Data | Compliance | Description | Data |
|---|---|---|---|---|---|
| Yes | Gutter Ponding | No | No | Curb Slope | 11.7 |
| No | Gutter Cross Slope (%) | 2.2 | | | |
