# Access Compliance Report Public Rights-of-Way (Curb Ramps)

Main Street: BEACHMONT\_AVE Cross Street: MEDFORD\_RD Location: SW

ADA ID: RPAT211007123732 Ramp Type: Type 1 - Perpendicular Diagonal Initial Pass/Fail: Pass Overall Compliance: No Severity Score: 26

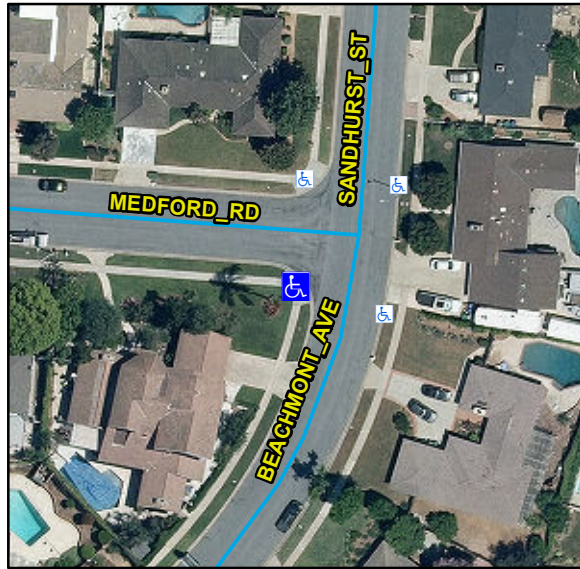
| Compliance | Description | Data | Compliance | Description | Data |
|---|---|---|---|---|---|
| No | Landing Width (in) | N/A | N/A | Flare Slope RT (%) | 5.2 |
| No | Landing Run Slope (%) | N/A | N/A | Flare Traversable RT | No |
| No | Landing Cross Slope (%) | N/A | No | DWS Provided | No |
| No | Gutter Run Slope (%) | 5.9 | | Road Cross Slope (%) | 7 |

Remove & Replace Curb Ramp With Two New Directional Ramps or Equivalent. Remove & Replace Gutter.
