# Access Compliance Report Public Rights-of-Way (Curb Ramps)

Main Street: MEDFORD\_RD Cross Street: SANDHURST\_ST Location: NW

ADA ID: RPAT211007124337 Ramp Type: Type 1 - Perpendicular Diagonal Initial Pass/Fail: Fail Overall Compliance: No Severity Score: 30

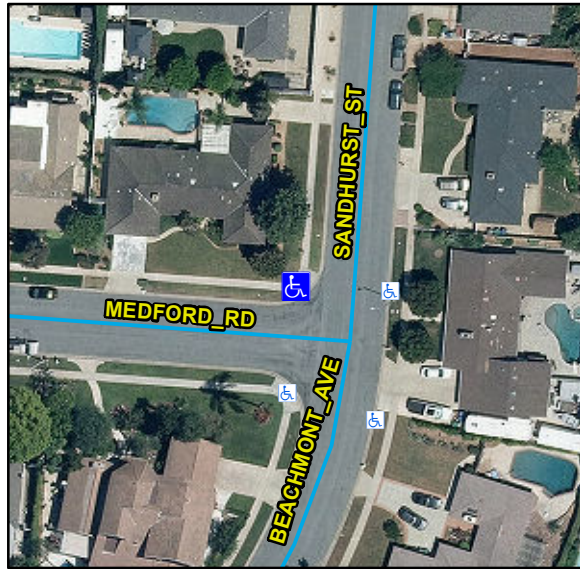
| Compliance | Description | Data | Compliance | Description | Data |
|---|---|---|---|---|---|
| No | Ramp Run Slope (%) | 9.1 | N/A | Flare Slope LT (%) | N/A |
| No | Ramp Cross Slope (%) | 5.5 | N/A | Flare Traversable LT | N/A |

Remove & Replace Curb Ramp With Two New Directional Ramps or Equivalent.

R304.2.2, R304.5.3, STD 1115

Total Cost: \$ 6160

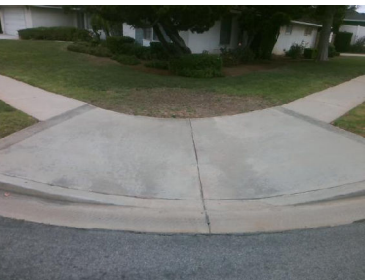
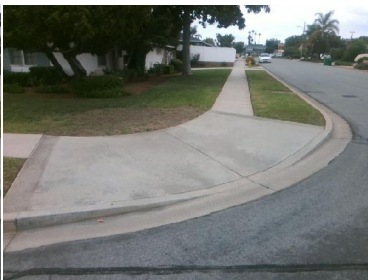
| Compliance | Description | Data | Compliance | Description | Data |
|---|---|---|---|---|---|
| Yes | Overall Surface Condition: Acceptable | | Yes | Perp Joint Present | Yes |
