# Access Compliance Report Public Rights-of-Way (Curb Ramps)

Main Street: SANDHURST\_ST Cross Street: NEWTON\_AVE Location: SW

ADA ID: RPAT211007124702 Ramp Type: Type 1 - Perpendicular Diagonal Initial Pass/Fail: Pass Overall Compliance: No Severity Score: 22

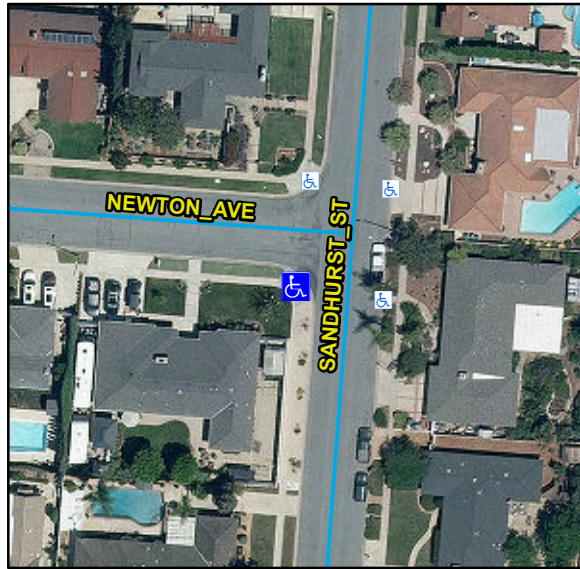
| Compliance | Description | Data | Compliance | Description | Data |
|---|---|---|---|---|---|
| No | Landing Cross Slope (%) | N/A | No | DWS Provided | No |
| No | Gutter Cross Slope (%) | 6.5 | | | |

Remove & Replace Curb Ramp With Two New Directional Ramps or Equivalent. Remove & Replace Gutter.

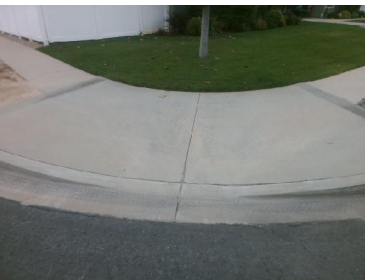
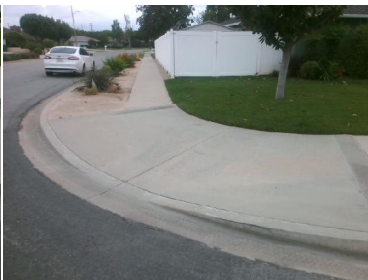
| Compliance | Description | Data | Compliance | Description | Data |
|---|---|---|---|---|---|
| Yes | Overall Surface Condition: Acceptable | | No | Perp Joint Present | No |
