# Access Compliance Report Public Rights-of-Way (Curb Ramps)

Main Street: NEWTON\_AVE Cross Street: SANDHURST\_ST Location: NW

ADA ID: RPAT211007125122 Ramp Type: Type 1 - Perpendicular Diagonal Initial Pass/Fail: Pass Overall Compliance: No Severity Score: 25

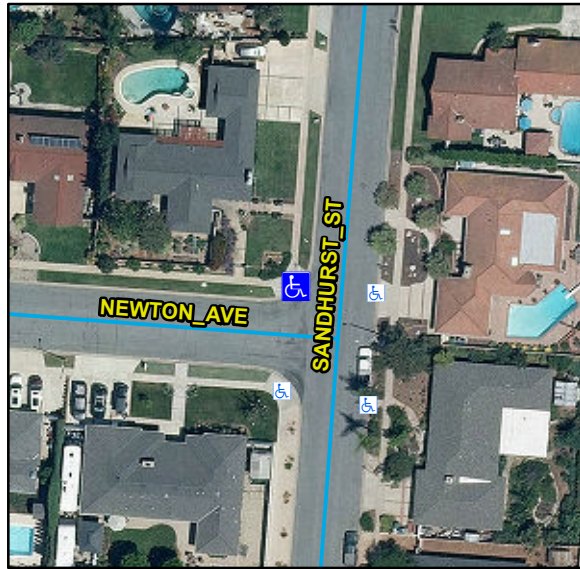
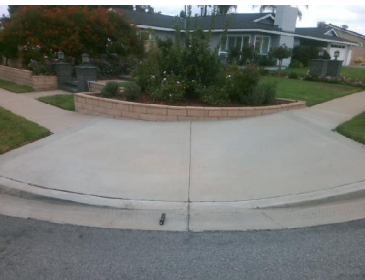
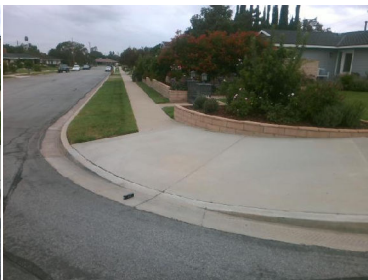
| Compliance | Description | Data | Compliance | Description | Data |
|---|---|---|---|---|---|
| No | Landing Width (in) | N/A | N/A | Flare Slope RT (%) | 11.6 |
| No | Landing Run Slope (%) | N/A | N/A | Flare Traversable RT | No |
| No | Landing Cross Slope (%) | N/A | No | DWS Provided | No |
| No | Gutter Run Slope (%) | 9 | | Road Cross Slope (%) | 6.3 |
| No | Gutter Cross Slope (%) | 4.3 | | | |

Remove & Replace Curb Ramp With Two New Directional Ramps or Equivalent. Remove & Replace Gutter.
