# Access Compliance Report Public Rights-of-Way (Curb Ramps)

Main Street: SANDHURST\_ST Cross Street: ERVIN\_LN Location: SW

ADA ID: RPAT211007125607 Ramp Type: Type 1 - Perpendicular Diagonal Initial Pass/Fail: Pass Overall Compliance: No Severity Score: 25

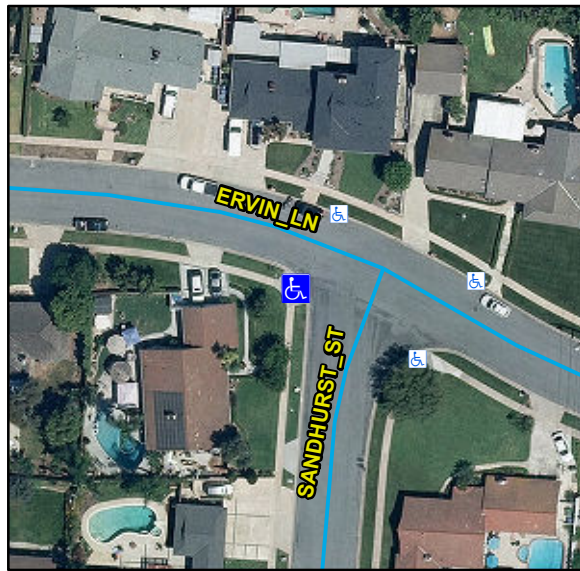
| Compliance | Description | Data | Compliance | Description | Data |
|---|---|---|---|---|---|
| No | Landing Width (in) | N/A | N/A | Flare Slope RT (%) | 4.6 |
| No | Landing Run Slope (%) | N/A | N/A | Flare Traversable RT | No |
| No | Landing Cross Slope (%) | N/A | No | DWS Provided | No |
| No | Gutter Run Slope (%) | 6.8 | | Road Cross Slope (%) | 6.9 |

Remove & Replace Curb Ramp With Two New Directional Ramps or Equivalent. Remove & Replace Gutter.

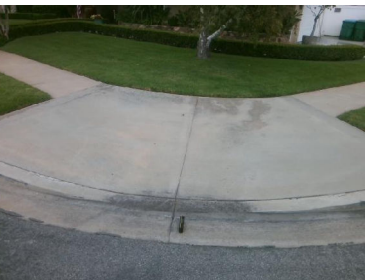
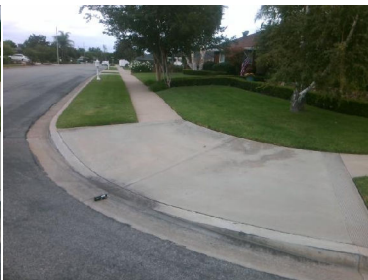
| Compliance | Description | Data | Compliance | Description | Data |
|---|---|---|---|---|---|
| Yes | Overall Surface Condition: Acceptable | | No | Perp Joint Present | No |
