# Access Compliance Report Public Rights-of-Way (Curb Ramps)

Main Street: ERVIN\_LN Cross Street: SANDHURST\_ST Location: SE

ADA ID: RPAT211007125941 Ramp Type: Type 1 - Perpendicular Diagonal Initial Pass/Fail: Pass Overall Compliance: No Severity Score: 25

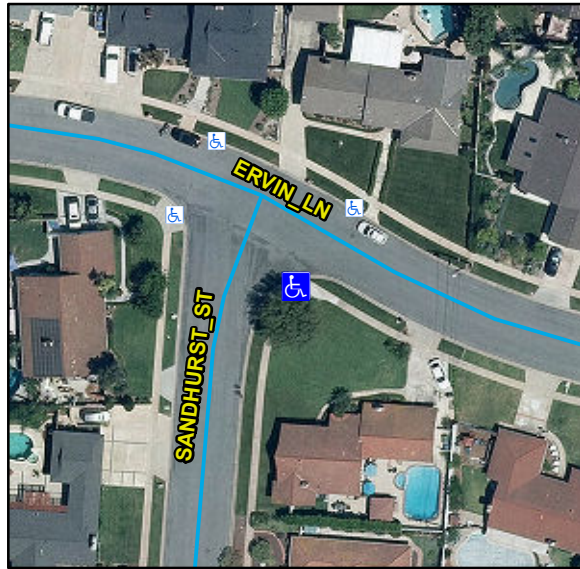
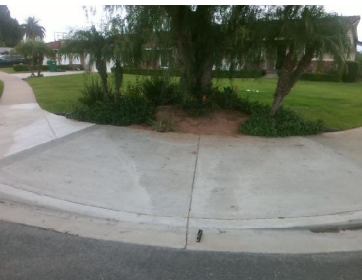
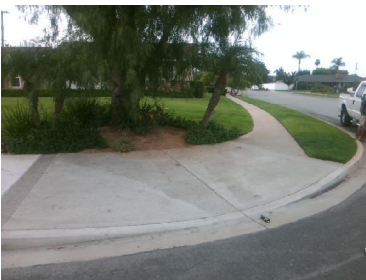
| Compliance | Description | Data | Compliance | Description | Data |
|---|---|---|---|---|---|
| No | Landing Width (in) | N/A | N/A | Flare Slope RT (%) | 5.3 |
| No | Landing Run Slope (%) | N/A | N/A | Flare Traversable RT | No |
| No | Landing Cross Slope (%) | N/A | No | DWS Provided | No |
| No | Gutter Run Slope (%) | 6.3 | | Road Cross Slope (%) | 6.5 |

Remove & Replace Curb Ramp With Two New Directional Ramps or Equivalent. Remove & Replace Gutter.
