# Access Compliance Report Public Rights-of-Way (Curb Ramps)

Main Street: **BRENAN\_WAY** Cross Street: **MILFORD\_RD** Location: **NW**

ADA ID: **RPAT211007135928** Ramp Type: **Type 6 - Directional 1** Initial Pass/Fail: **Fail** Overall Compliance: **No** Severity Score: **15**

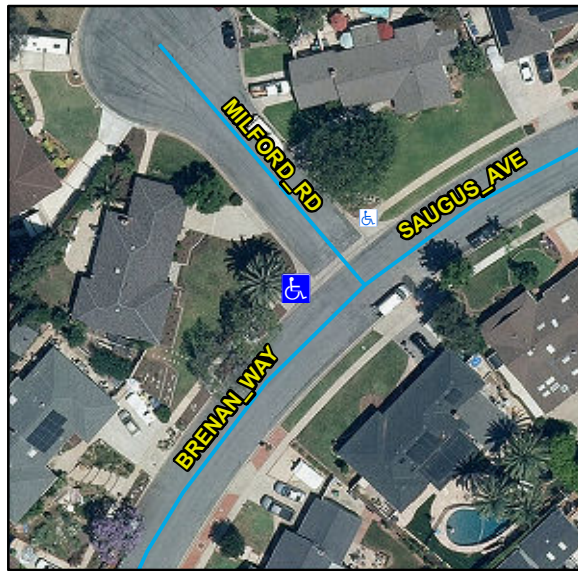
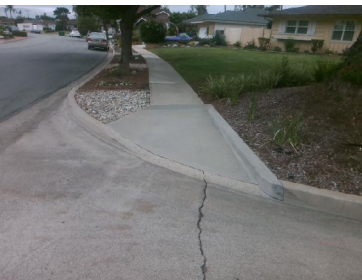
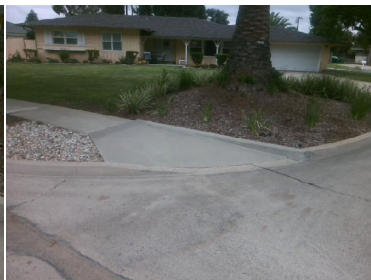
| Compliance | Description | Data | Compliance | Description | Data |
|---|---|---|---|---|---|
| <b>No</b> | Ramp Cross Slope (%) | <b>6</b> | <b>N/A</b> | Flare Traversable LT | <b>N/A</b> |

**Remove & Replace Curb Ramp With Two New Directional Ramps or Equivalent.**

**R304.5.3, STD 1115**
