# Access Compliance Report Public Rights-of-Way (Curb Ramps)

Main Street: MILFORD\_RD Cross Street: SAUGUS\_AVE Location: NE

ADA ID: RPAT211007140250 Ramp Type: Type 6 - Directional 1 Initial Pass/Fail: Fail Overall Compliance: No Severity Score: 2

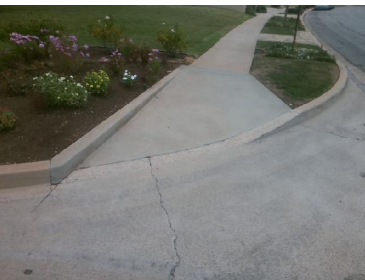
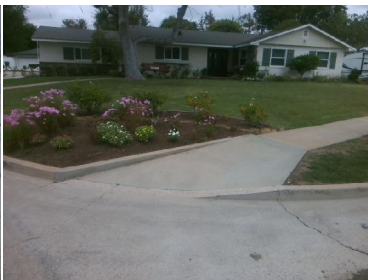
| Compliance | Description | Data | Compliance | Description | Data |
|---|---|---|---|---|---|
| No | Ramp Cross Slope (%) | 4.8 | N/A | Flare Traversable LT | N/A |

**Remove & Replace Curb Ramp With Two New Directional Ramps or Equivalent.**

**R304.5.3, STD 1115**
