# Access Compliance Report Public Rights-of-Way (Curb Ramps)

Main Street: SANDERSTEAD\_RD Cross Street: HOLT\_AVE Location: NW

ADA ID: RPAT211007141902 Ramp Type: Type 1 - Perpendicular Diagonal Initial Pass/Fail: Pass Overall Compliance: No Severity Score: 22

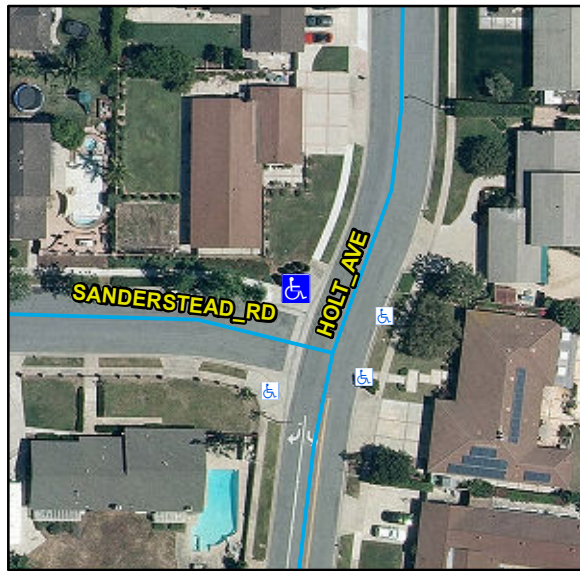
| Compliance | Description | Data | Compliance | Description | Data |
|---|---|---|---|---|---|
| No | Landing Width (in) | N/A | Yes | Flare Slope RT (%) | 5.5 |
| No | Landing Run Slope (%) | N/A | N/A | Flare Traversable RT | Yes |
| No | Landing Cross Slope (%) | N/A | No | DWS Provided | No |
| N/A | Landing Movement Obstructed? | Yes | N/A | DWS Contrast | N/A |
| | Landing Movement Type | Bushes | N/A | DWS Length (in) | N/A |
| Yes | Gutter Ponding | No | No | Curb Slope | 7.8 |
| Yes | Overall Surface Condition: Acceptable | | No | Perp Joint Present | No |

Remove & Replace Curb Ramp With Two New Directional Ramps or Equivalent.

R304.2.2, R204.3, R304.2.1, R304.2.2-Perp, R304.3.2-Para, R304.5.3, R305, STD 1115
