# Access Compliance Report Public Rights-of-Way (Curb Ramps)

Main Street: HOLT\_AVE Cross Street: SANDERSTEAD\_RD Location: SW

ADA ID: RPAT211007142433 Ramp Type: Type 1 - Perpendicular Diagonal Initial Pass/Fail: Pass Overall Compliance: No Severity Score: 20

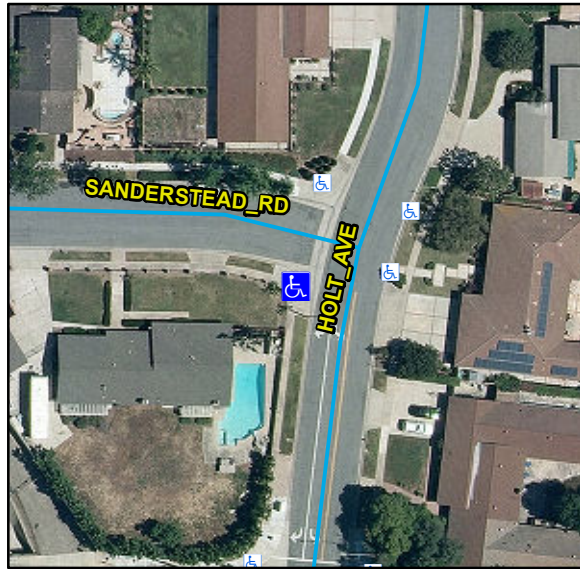
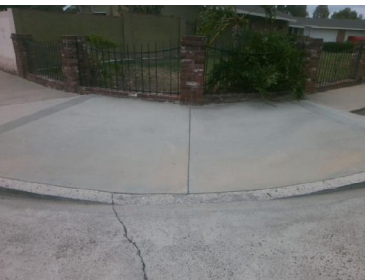
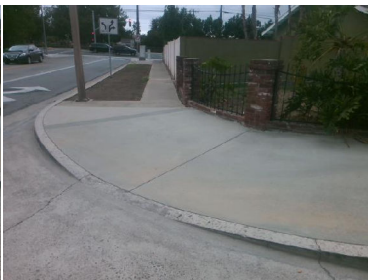
| Compliance | Description | Data | Compliance | Description | Data |
|---|---|---|---|---|---|
| No | Landing Width (in) | N/A | N/A | Flare Slope RT (%) | 9.4 |
| No | Landing Run Slope (%) | N/A | N/A | Flare Traversable RT | No |
| No | Landing Cross Slope (%) | N/A | No | DWS Provided | No |
| No | Gutter Cross Slope (%) | 3 | | | |

Remove & Replace Curb Ramp With Two New Directional Ramps or Equivalent. Remove & Replace Gutter.
