# Access Compliance Report Public Rights-of-Way (Curb Ramps)

Main Street: BRYCE\_PL Cross Street: RUSHMORE\_LN Location: NE

ADA ID: RPAT211007143810 Ramp Type: Type 1 - Perpendicular Diagonal Initial Pass/Fail: Fail Overall Compliance: No Severity Score: 2

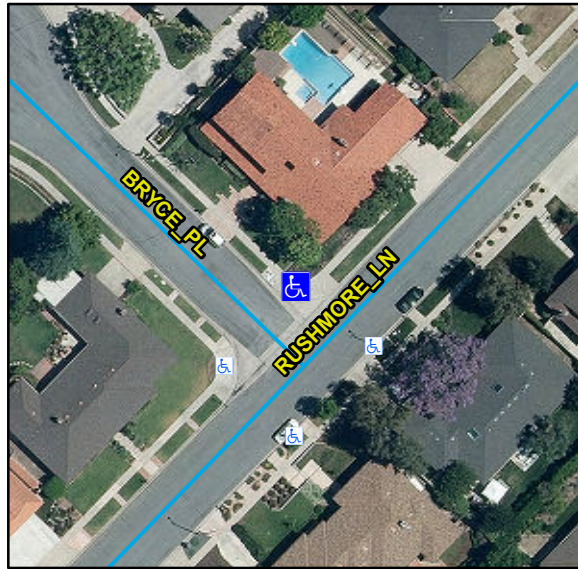
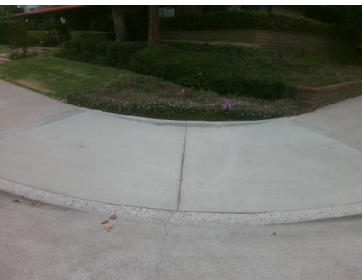
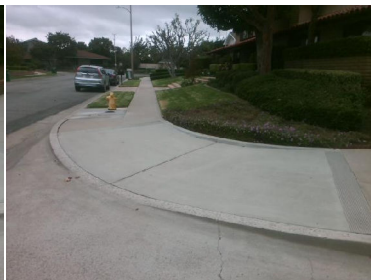
| Compliance | Description | Data | Compliance | Description | Data |
|---|---|---|---|---|---|
| No | Ramp Cross Slope (%) | 2.8 | N/A | Flare Traversable LT | N/A |

Remove & Replace Curb Ramp With Two New Directional Ramps or Equivalent.

R304.5.3, STD 1115
