# Access Compliance Report Public Rights-of-Way (Curb Ramps)

Main Street: RUSHMORE\_LN Cross Street: BRYCE\_PL Location: W

ADA ID: RPAT211007144150 Ramp Type: Type 1 - Perpendicular Diagonal Initial Pass/Fail: Pass Overall Compliance: No Severity Score: 20

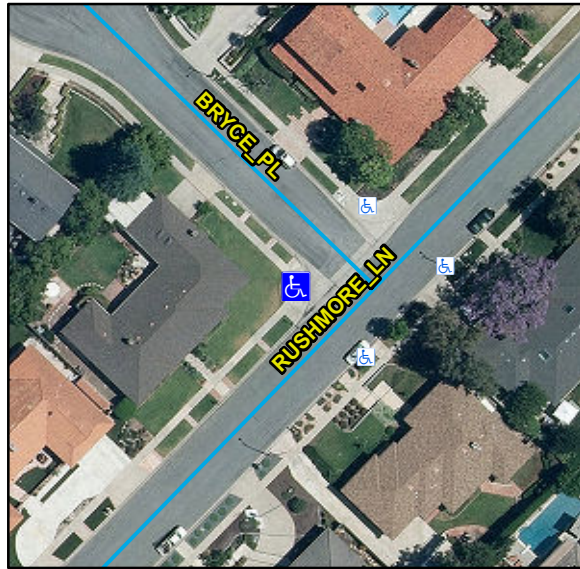
| Compliance | Description | Data | Compliance | Description | Data |
|---|---|---|---|---|---|
| N/A | Ramp Length (in) | 113 | N/A | Flare Type LT | |
| Yes | Ramp Width (in) | 64 | | | Sloped |
| Yes | Ramp Run Slope (%) | 5.4 | N/A | Flare Slope LT (%) | 3.8 |
| Yes | Ramp Cross Slope (%) | 0.6 | N/A | Flare Traversable LT | No |
| No | Landing Width (in) | N/A | N/A | Flare Slope RT (%) | 7.2 |
| No | Landing Run Slope (%) | N/A | N/A | Flare Traversable RT | No |
| No | Landing Cross Slope (%) | N/A | No | DWS Provided | No |

Remove & Replace Curb Ramp With Two New Directional Ramps or Equivalent.
