# Access Compliance Report Public Rights-of-Way (Curb Ramps)

Main Street: RUSHMORE\_LN Cross Street: LEAFWOOD\_LN Location: SW

ADA ID: RPAT211007144840 Ramp Type: Type 1 - Perpendicular Diagonal Initial Pass/Fail: Fail Overall Compliance: No Severity Score: 2

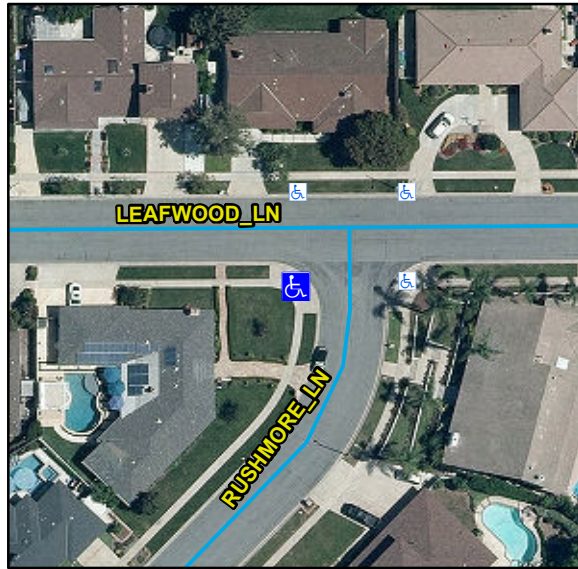
| Compliance | Description | Data | Compliance | Description | Data |
|---|---|---|---|---|---|
| No | Ramp Cross Slope (%) | 3.3 | N/A | Flare Traversable LT | N/A |
| N/A | Gutter Ponding | N/A | No | Curb Slope | 5.7 |

Remove & Replace Curb Ramp With Two New Directional Ramps or Equivalent.

R304.2.2, R204.3, R304.5.3, STD 1115
