# Access Compliance Report Public Rights-of-Way (Curb Ramps)

Main Street: LEAFWOOD\_LN Cross Street: RUSHMORE\_LN Location: SE

ADA ID: RPAT211007145109 Ramp Type: Type 1 - Perpendicular Diagonal Initial Pass/Fail: Fail Overall Compliance: No Severity Score: 15

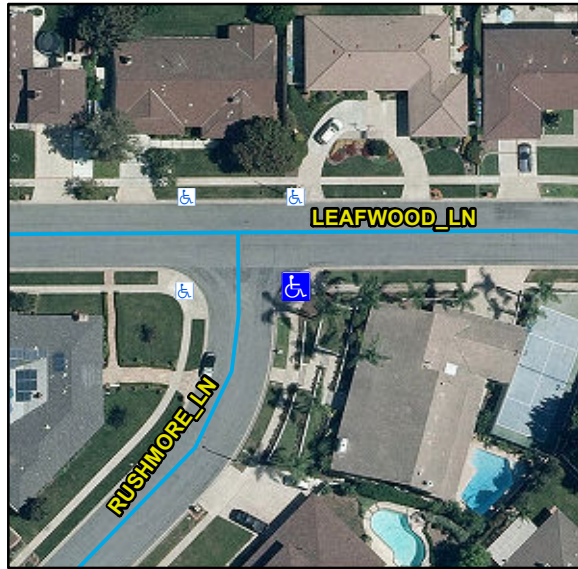
| Compliance | Description | Data | Compliance | Description | Data |
|---|---|---|---|---|---|
| No | Ramp Cross Slope (%) | 5.8 | N/A | Flare Traversable LT | N/A |

Remove & Replace Curb Ramp With Two New Directional Ramps or Equivalent.

R304.2.2, R204.3, R304.5.3, STD 1115
