# Access Compliance Report Public Rights-of-Way (Curb Ramps)

Main Street: YELLOWSTONE\_DR Cross Street: RUSHMORE\_LN Location: NE

ADA ID: RPAT211007150348 Ramp Type: Type 1 - Perpendicular Diagonal Initial Pass/Fail: Fail Overall Compliance: No Severity Score: 2

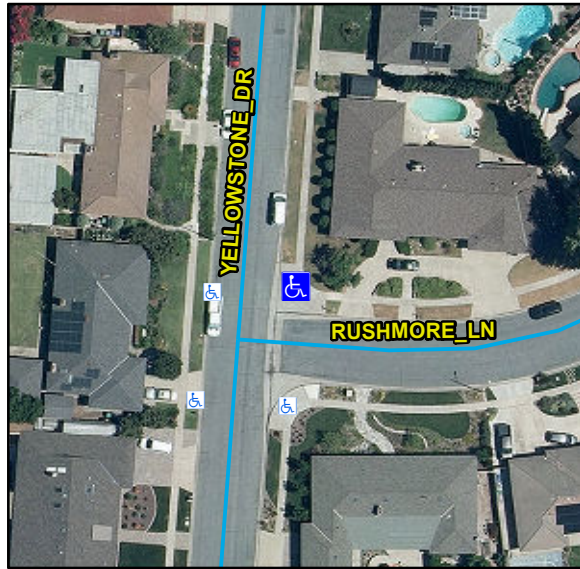
| Compliance | Description | Data | Compliance | Description | Data |
|---|---|---|---|---|---|
| No | Ramp Cross Slope (%) | 3.2 | N/A | Flare Traversable LT | N/A |

**Remove & Replace Curb Ramp With Two New Directional Ramps or Equivalent.**

**R304.5.3, STD 1115**

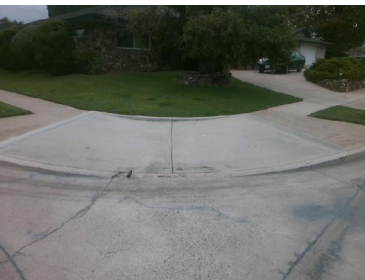
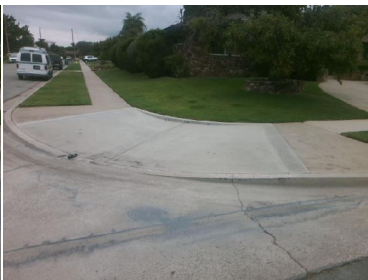
| Compliance | Description | Data | Compliance | Description | Data |
|---|---|---|---|---|---|
| Yes | Overall Surface Condition: <b>Acceptable</b> | | Yes | Perp Joint Present | Yes |
