# Access Compliance Report Public Rights-of-Way (Curb Ramps)

| Main Street: RUSHMORE_LN | | Cross Street: YELLOWSTONE_DR | | Location: | SE |
| ADA ID: RPAT211007150647 | Ramp Type:Type 1 - Perpendicular Diagonal Initial Pass/Fail: Fail | | Overall Compliance: No | Severity Score: | 15 |

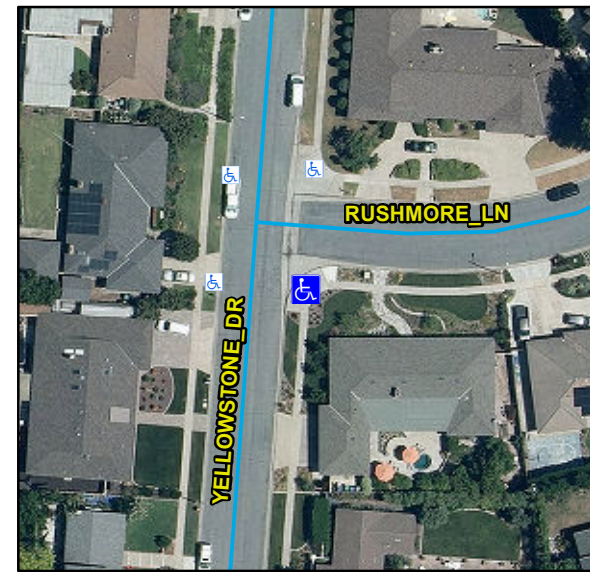
| Compliance | Description | Data | Compliance | Description | Data |
|---|---|---|---|---|---|
| No | Ramp Run Slope (%) | 8.5 | N/A | Flare Slope LT (%) | N/A |

**Remove & Replace Curb Ramp With Two New Directional Ramps or Equivalent.**

**R304.2.2, STD 1115**
