# Access Compliance Report

## Public Rights-of-Way

### (Curb Ramps)

| Main Street: KENNETH_DR | | Cross Street: DEL_REY_DR | | Location: | SW |

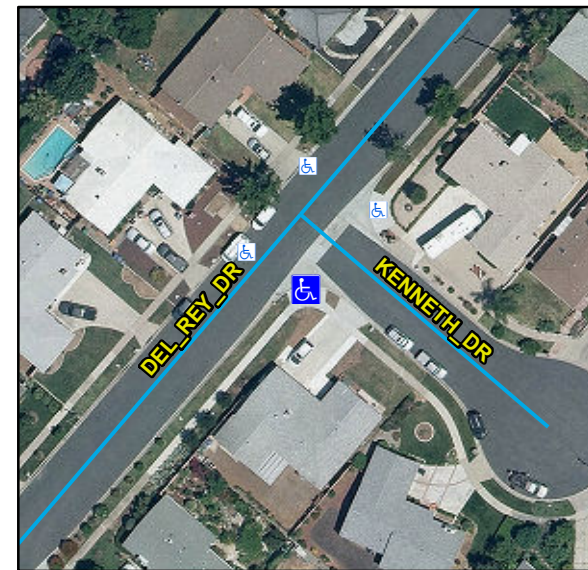
| ADA ID: RPAT211008095335 | Ramp Type: Type 3 - Combination 1 | Initial Pass/Fail: Fail | Overall Compliance: No | Severity Score: | 30 |

| Compliance | Description | Data | Compliance | Description | Data |
|---|---|---|---|---|---|
| No | Ramp Run Slope LT (%) | 10.8 | Yes | Ramp Run Slope RT (%) | 7.9 |
| No | Ramp Cross Slope LT (%) | 5.5 | No | Ramp Cross Slope RT (%) | 4.5 |
| No | Ramp Run Slope (%) | 9.2 | N/A | Flare Slope LT (%) | N/A |
| No | Ramp Cross Slope (%) | 3.3 | N/A | Flare Traversable LT | N/A |

**Remove & Replace Curb Ramp With Two New Directional Ramps or Equivalent.**

**R304.2.2, R304.5.3, R304.3.2, STD 1115**

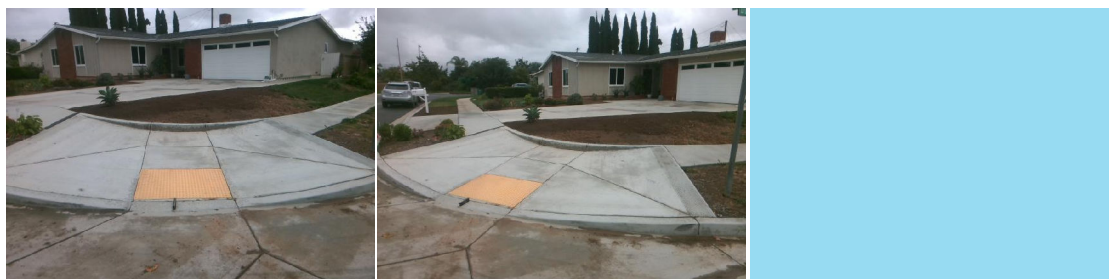
| Compliance | Description | Data | Compliance | Description | Data |
|---|---|---|---|---|---|
| N/A | Ramp Length LT (in) | 82 | N/A | Ramp Length RT (in) | 75 |
| Yes | Ramp Width LT (in) | 51 | Yes | Ramp Width RT (in) | 52 |
| N/A | Gutter Ponding | N/A | No | Curb Slope | 12.7 |
