# Access Compliance Report Public Rights-of-Way (Curb Ramps)

| Main Street: DEL_REY_DR | | Cross Street: KENNETH_DR | | Location: | SE |
| ADA ID: RPAT211008095800 | Ramp Type: Type 3 - Combination 1 | Initial Pass/Fail: Fail | Overall Compliance: No | Severity Score: | 16 |

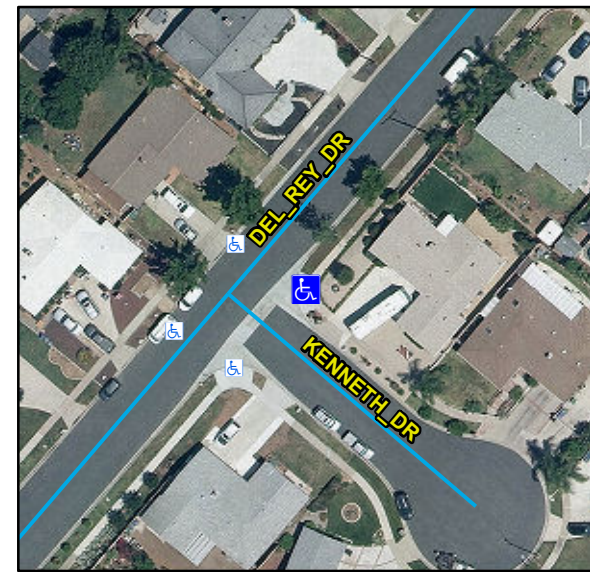
| Compliance | Description | Data | Compliance | Description | Data |
|---|---|---|---|---|---|
| Yes | Ramp Run Slope LT (%) | 0.3 | No | Ramp Run Slope RT (%) | 9.2 |
| No | Ramp Cross Slope LT (%) | 2.3 | No | Ramp Cross Slope RT (%) | 2.8 |
| No | Ramp Run Slope (%) | 8.9 | N/A | Flare Slope LT (%) | N/A |
| No | Ramp Cross Slope (%) | 2.8 | N/A | Flare Traversable LT | N/A |

**Remove & Replace Curb Ramp With Two New Directional Ramps or Equivalent.**

**R304.2.2, R304.5.3, R304.3.2, STD 1115**

Total Cost: \$ 6160

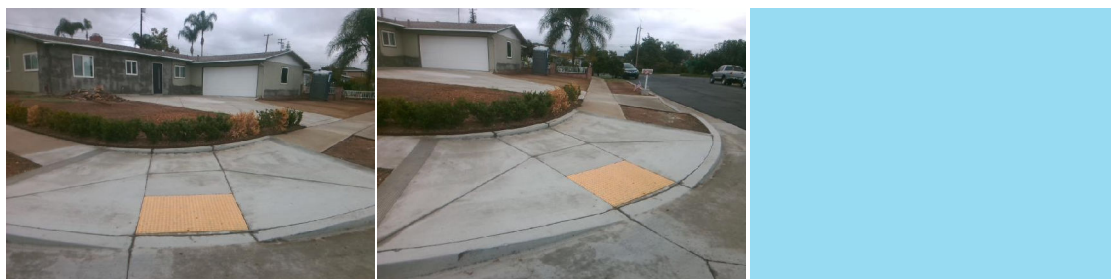
| Compliance | Description | Data | Compliance | Description | Data |
|---|---|---|---|---|---|
| N/A | Ramp Length LT (in) | 56 | N/A | Ramp Length RT (in) | 76 |
| Yes | Ramp Width LT (in) | 52 | Yes | Ramp Width RT (in) | 51 |
| N/A | Ramp Length (in) | 73 | N/A | Flare Type LT | |
| Yes | Ramp Width (in) | 50 | | | N/A |
