# Access Compliance Report Public Rights-of-Way (Curb Ramps)

Main Street: CAMEO\_DR Cross Street: DEL\_REY\_DR Location: SW

ADA ID: RPAT211008100232 Ramp Type: Type 1 - Perpendicular Diagonal Initial Pass/Fail: Fail Overall Compliance: No Severity Score: 30

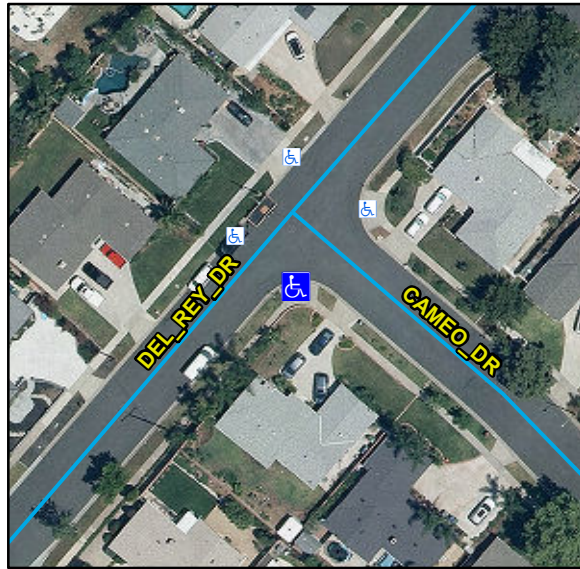
| Compliance | Description | Data | Compliance | Description | Data |
|---|---|---|---|---|---|
| No | Ramp Cross Slope (%) | 7.4 | N/A | Flare Traversable LT | N/A |

Remove & Replace Curb Ramp With Two New Directional Ramps or Equivalent.

R304.5.3, STD 1115

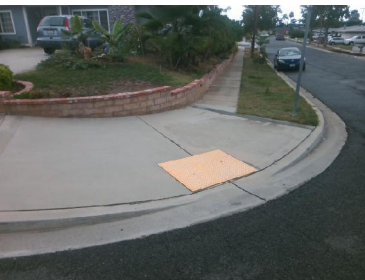
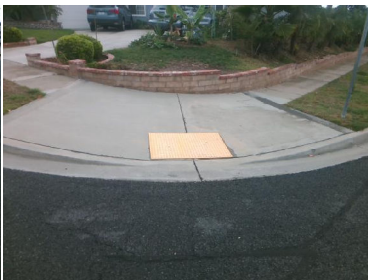
| Compliance | Description | Data | Compliance | Description | Data |
|---|---|---|---|---|---|
| Yes | Overall Surface Condition: Acceptable | | Yes | Perp Joint Present | Yes |
