# Access Compliance Report Public Rights-of-Way (Curb Ramps)

| Main Street: DEL_REY_DR | | Cross Street: CAMEO_DR | | Location: | SE |
| ADA ID: RPAT211008100443 | Ramp Type:Type 1 - Perpendicular Diagonal Initial Pass/Fail: Fail | | Overall Compliance: No | Severity Score: | 15 |

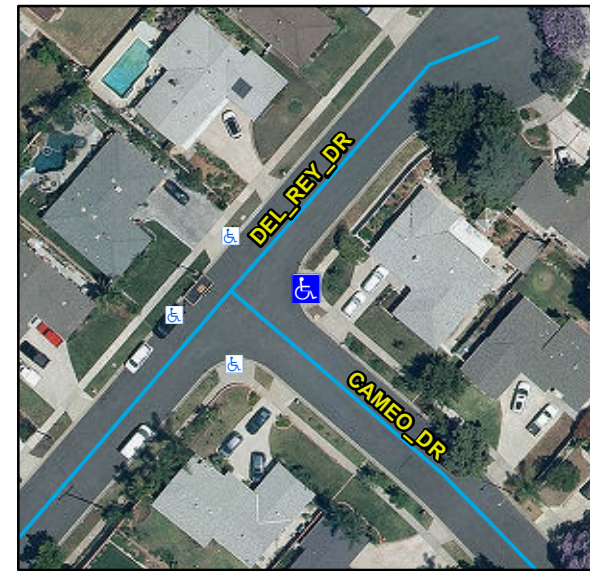
| Compliance | Description | Data | Compliance | Description | Data |
|---|---|---|---|---|---|
| No | Ramp Cross Slope (%) | 5.1 | N/A | Flare Traversable LT | N/A |

**Remove & Replace Curb Ramp With Two New Directional Ramps or Equivalent.**

**R304.5.3, STD 1115**

Total Cost: \$ 6160
