# Access Compliance Report Public Rights-of-Way (Curb Ramps)

Main Street: DEAN\_ST Cross Street: CAMEO\_DR Location: NW

ADA ID: RPAT211008101032 Ramp Type: Type 1 - Perpendicular Diagonal Initial Pass/Fail: Fail Overall Compliance: No Severity Score: 0

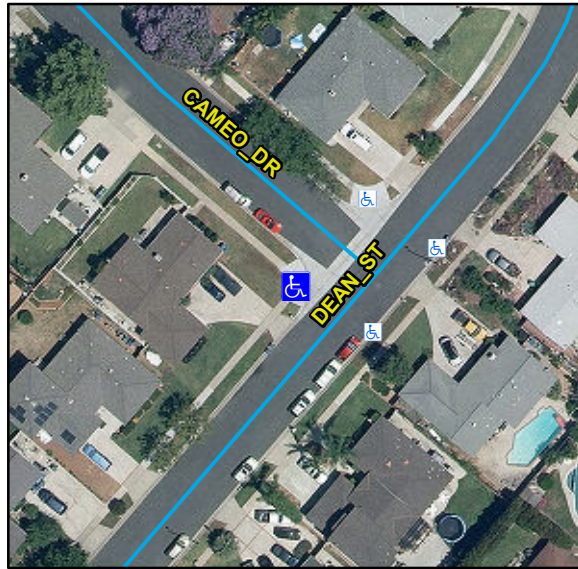
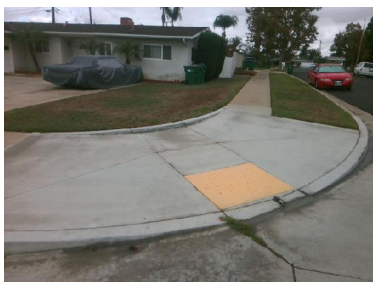
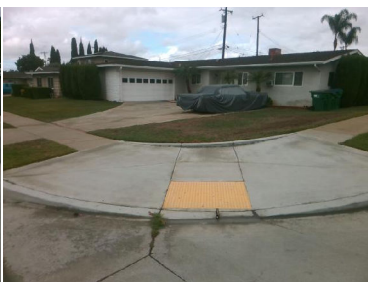
| Compliance | Description | Data | Compliance | Description | Data |
|---|---|---|---|---|---|
| Yes | Ramp Cross Slope (%) | 4.5 | N/A | Flare Traversable LT | N/A |
| N/A | Gutter Ponding | N/A | No | Curb Slope | 7.3 |

Remove & Replace Curb Ramp With Two New Directional Ramps or Equivalent.

R304.2.2, STD 1115
