# Access Compliance Report Public Rights-of-Way (Curb Ramps)

Main Street: TIFFANY\_PL Cross Street: DEL\_REY\_DR Location: SW

ADA ID: RPAT211008102230 Ramp Type: Type 1 - Perpendicular Diagonal Initial Pass/Fail: Fail Overall Compliance: No Severity Score: 2

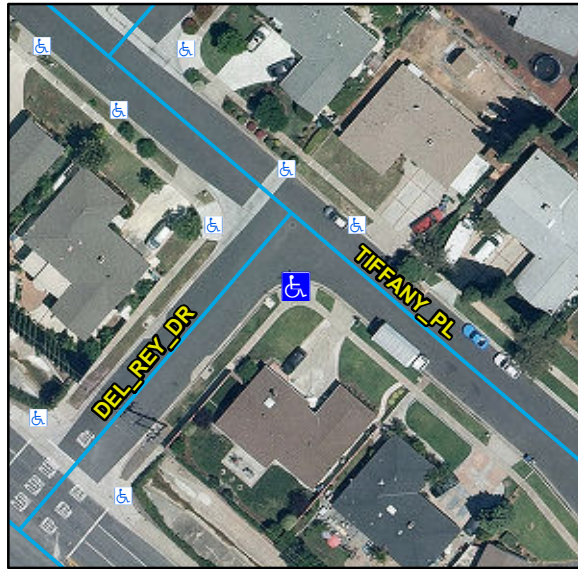
R304.2.2, R304.5.3, STD 1115

| Compliance | Description | Data | Compliance | Description | Data |
|---|---|---|---|---|---|
| No | Ramp Cross Slope (%) | 3.8 | N/A | Flare Traversable LT | N/A |

Remove & Replace Curb Ramp With Two New Directional Ramps or Equivalent.
