# Access Compliance Report Public Rights-of-Way (Curb Ramps)

| Main Street: RAINBOW_DR | | Cross Street: RAINBOW_DR | | Location: | NE |
| ADA ID: RPAT211008103421 | Ramp Type:Type 1 - Perpendicular Diagonal Initial Pass/Fail: Fail | | Overall Compliance: No | Severity Score: | 2 |

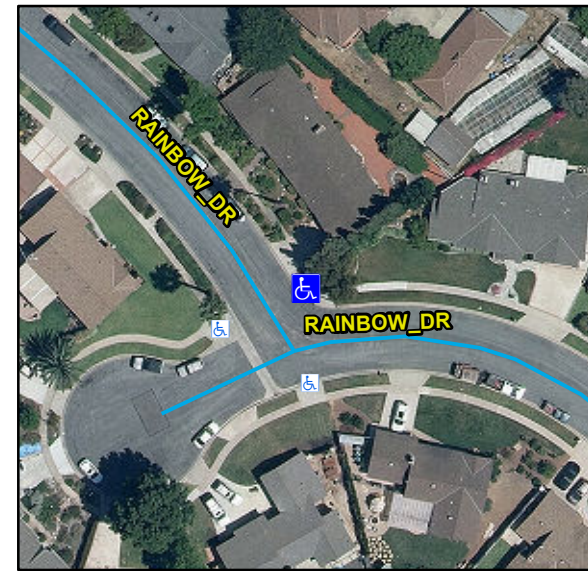
| Compliance | Description | Data | Compliance | Description | Data |
|---|---|---|---|---|---|
| No | Ramp Cross Slope (%) | 4.1 | N/A | Flare Traversable LT | N/A |

**Remove & Replace Curb Ramp With Two New Directional Ramps or Equivalent.**

**R304.2.2, R304.5.3, STD 1115**
