# Access Compliance Report Public Rights-of-Way (Curb Ramps)

Main Street: RAINBOW\_DR Cross Street: RAINBOW\_DR Location: NW

ADA ID: RPAT211008103658 Ramp Type: Type 1 - Perpendicular Diagonal Initial Pass/Fail: Pass Overall Compliance: No Severity Score: 22

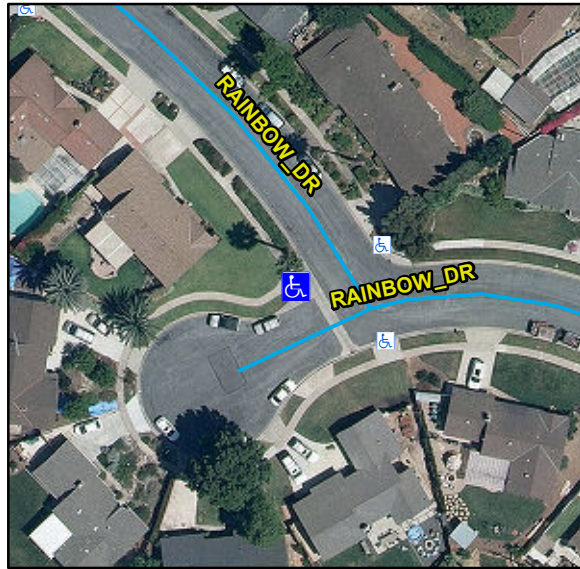
R304.2.2, R204.3, R304.2.1, R304.2.2-Perp, R304.3.2-Para, R304.5.3, R305, STD 1115

Remove & Replace Curb Ramp With Two New Directional Ramps or Equivalent.

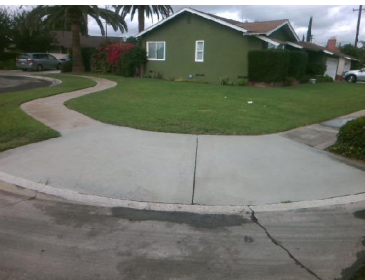
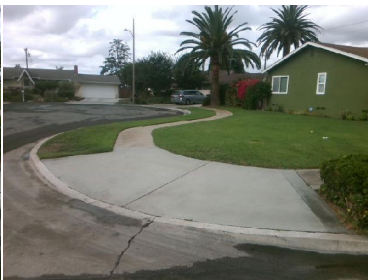
| Compliance | Description | Data | Compliance | Description | Data |
|---|---|---|---|---|---|
| No | Landing Width (in) | N/A | N/A | Flare Slope RT (%) | 6 |
| No | Landing Run Slope (%) | N/A | N/A | Flare Traversable RT | No |
| No | Landing Cross Slope (%) | N/A | No | DWS Provided | No |
| Yes | Gutter Ponding | No | No | Curb Slope | 6.9 |
