# Access Compliance Report Public Rights-of-Way (Curb Ramps)

| Main Street: RAINBOW_DR | | Cross Street: RAINBOW_DR | | Location: | S |
| ADA ID: RPAT211008104012 | Ramp Type:Type 1 - Perpendicular | Initial Pass/Fail: Pass | Overall Compliance: No | Severity Score: | 22 |

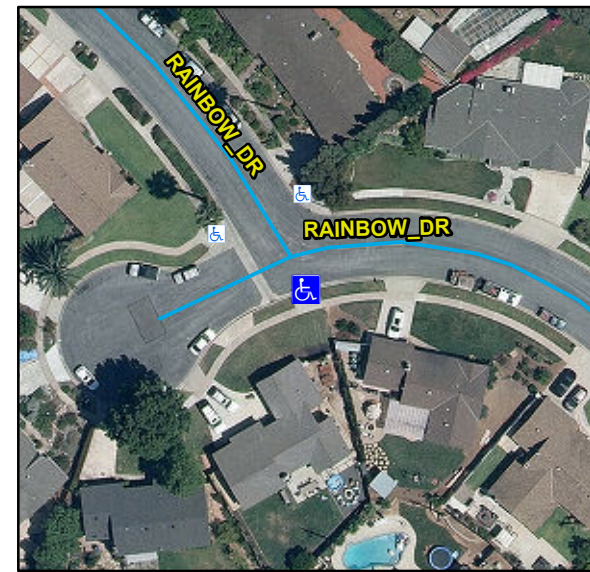
| Compliance | Description | Data | Compliance | Description | Data |
|---|---|---|---|---|---|
| No | Landing Width (in) | N/A | N/A | Flare Slope RT (%) | 8.7 |
| No | Landing Run Slope (%) | N/A | N/A | Flare Traversable RT | No |
| No | Landing Cross Slope (%) | N/A | No | DWS Provided | No |

Possible Solutions:

Remove & Replace Entire Ramp.

R204.3, R304.2.1, R304.2.2-Perp, R304.3.2-Para,  
R304.5.3, R305, STD 1115

Total Cost: \$ 3080
